Assessment of Major Bridges Along Nasarawa, Plateau, Bauchi and Gombe State Highway, Northern Central, Nigeria

Mlanga Victor Musa Kyauta Ekpo Ekpeyong Alhassan Iko David
Nigerian Building & Road Research Institute, 10 NBRRI Road/ I.T. Igbani Street, Jabi District, Abuja, FCT, Nigeria

Publication date: September 30th 2019

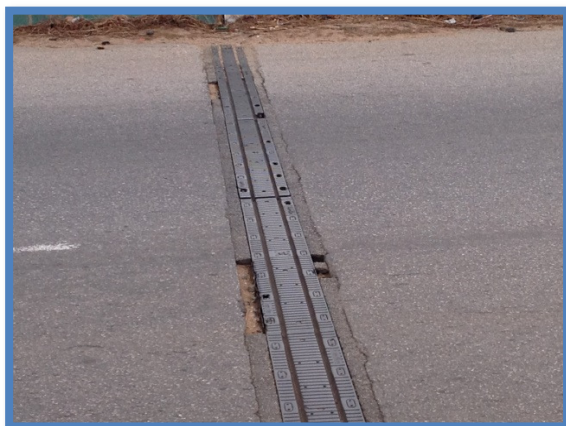
The Uke Bridge is located along Abuja-Keffi expressway on coordinate N08° 54.742' E07° 42.803' of the prime meridian. They each have 2 lanes. It was observed here that some deck expansion joints are deteriorated and leakage has been observed at the joints and the surrounding concrete. There is major spalling of bituminous wearing course at the adjacent decks near the joints. Also the stone pitching done to the embankments has partly dislodged due to poor concrete mix, allowing vegetation to grow and run off to then erode the slope. Several pile caps have become exposed and are vulnerable to scouring which would lead to exposure of the piles and weaken the pier supports. Concrete spalling 3 inches deep was observed on one of the piers. This has led to rebar exposure and loss of section. The exposed reinforcement bars can be seen to be undergoing corrosion due to the presence of water. Debris was observed to have lodged and settled between the girders on the pier caps due to deck joint leakage. This has encouraged unwanted vegetation growth which can limit longitudinal and lateral movement of the beams and lead to deterioration of the elastomeric bearings. Fig. 2.

Figure 3a. Deteriorating expansion joint

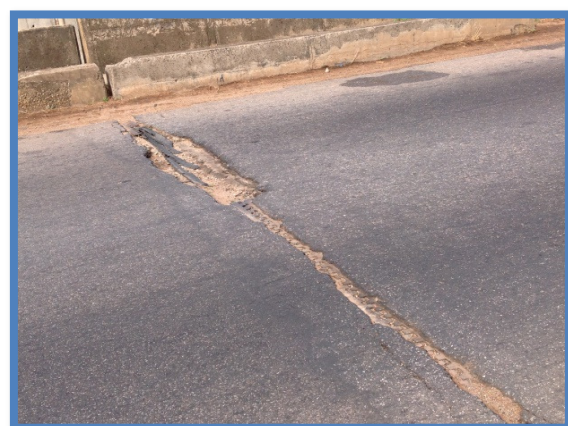
Figure 3b. Deteriorating expansion joint.

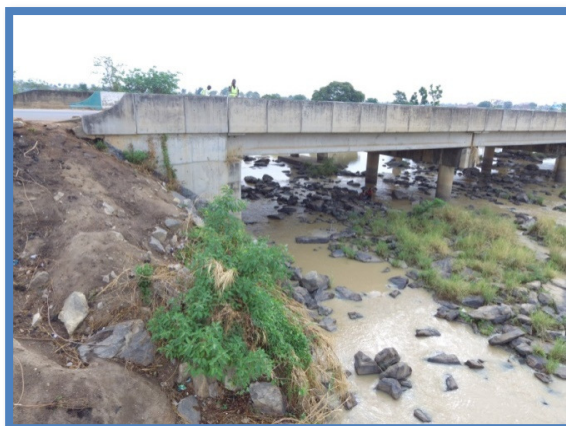
Figure 4. Dislodged stone pitching
Source: Field Survey 2019

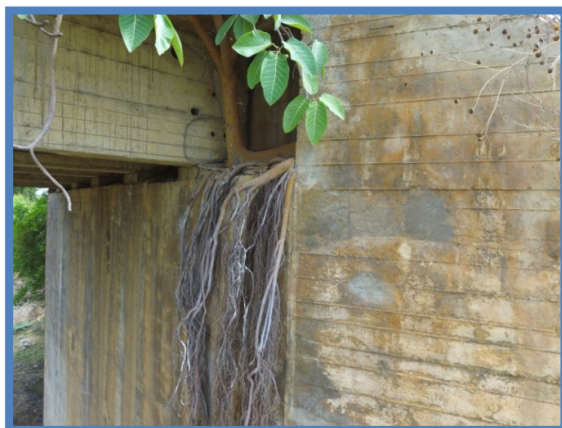
The stem wall from the Akwanga approach has a pronounced crack starting at its top and proceeding down to the bottom of the abutment. Its wing walls also have noticeable cracks. The team of engineers concluded that the stem wall has insufficient thickness and was poorly designed to withstand the cumulative weight of the backfill, bridge superstructure and traffic load. A tree was also observed to have grown on the bearing seat of the same abutment as shown in figure 7.

Figure 7. Tree growing on abutment seat.
Source: Field Survey 2019

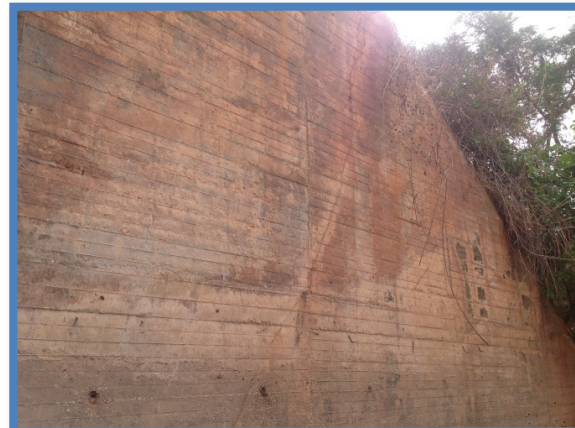
Figure 8. Pronounced crack on wing wall.

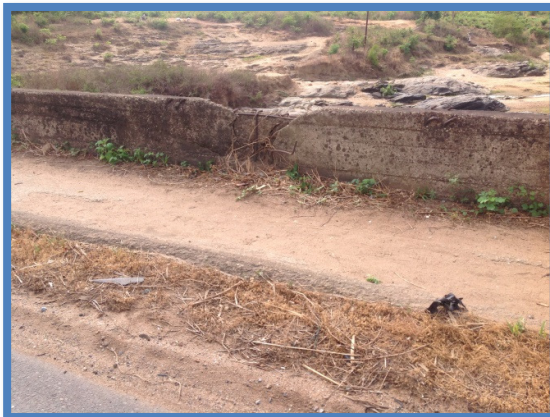
Figure 9.Major spalling of crash barrier
Source: Field Survey 2019

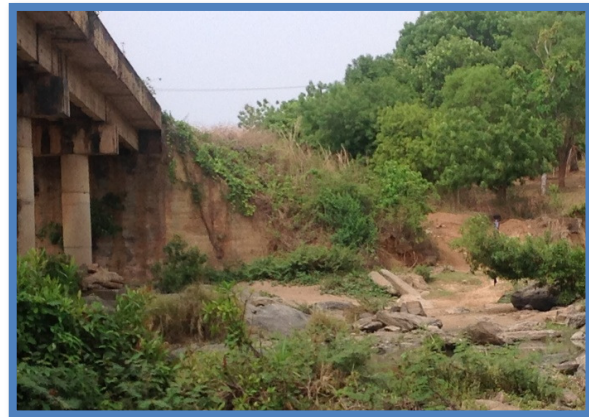
Lastly, the engineers observed that the embankments of the bridge had been left unprotected without stone pitching or any other erosion-preventive treatment. Thus erosion and landslide due to runoff has removed much of the embankment backfill and trees have grown directly behind the wing wall.

Figure 10.Unwanted vegetation on embankment.

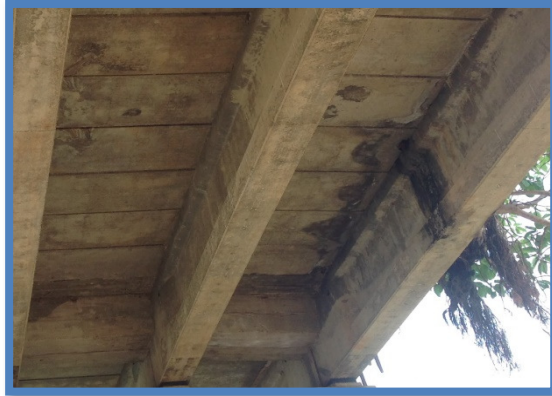
The Mada River flows under this bridge. On the bridge deck, major spalling is occurring on the headers adjacent to the expansion joints and debris has infiltrated the joints. Railings are also missing due to vandalism. This bridge has two large trees growing on the bridge fascia. The team of engineers observed that some drainage pipes on the deck are blocked and this has led to water being stagnant on the deck during rainfall. This has encouraged the growth of the trees.

Figure 12.Blocked drain and tree growth.
Source: Field Survey 2019

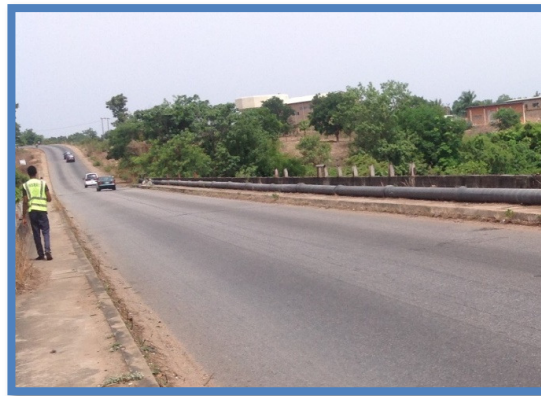
Figure 13.Missing railings due to vandalism

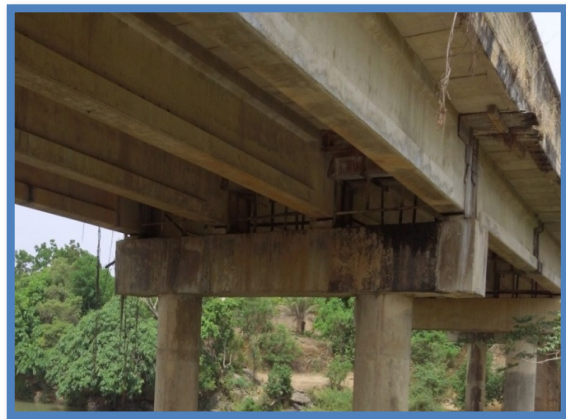
At some expansion joints under the soffit of the deck and also on the sides of the girders, decaying formwork is noticeably still in places years after the conclusion of the structure. This has led to the debris being lodged in the expansion joints, limiting movement of the bridge. Concrete spalling under the soffit of the deck is noticeable around these areas due to weakening of the concrete by retained water. Cracks 2mm wide were observed on some piers below the level normally submerged in water. The team concluded this happened as a result of poor concrete mix during construction of the piers, resulting in thermal cracks to occur. Lastly, some pile caps are also exposed and vulnerable to scouring.

Figure 15.Formwork observed under deck.

7. De-silting of drain pipes and installation of drain filters and seals where necessary.
8. Re-installation of missing railings.
9. Removal of decaying formwork still in place under the soffit and of the sides of the girders of the Gwanje Bridge.

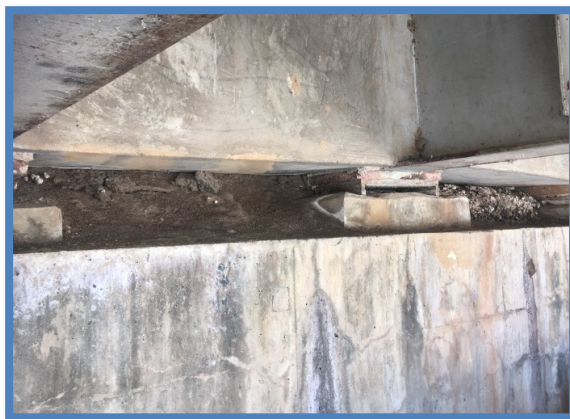
Figure 17.Soil loss from roadway approach.
Source: Field Survey 2019

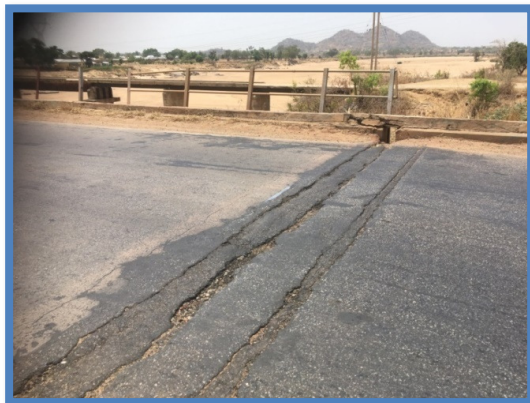
Figure 19.Spalling on approach joint.

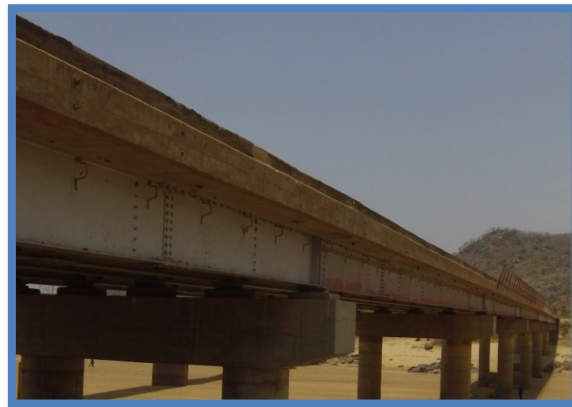
The team also noted that a lot of steel pipe bridge railings were missing, removed by vandals. This has left long distances along the bridge unprotected by any sort of barrier. Shrubs were found to have grown on the bearing seats due to accumulation of debris. It was observed that the channel bed had eroded and this has left some of the pile caps vulnerable to scouring.

Figure 20.Missing railings due to vandalism.

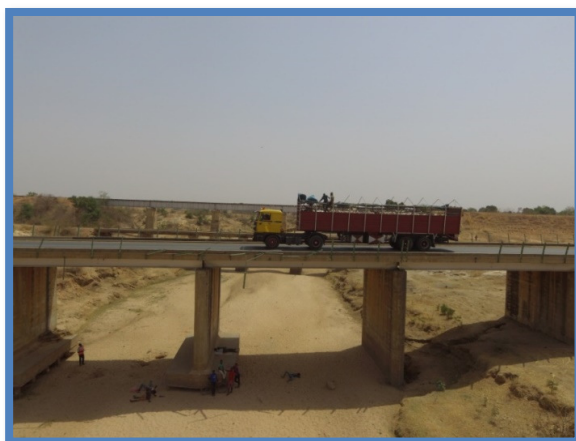
The bridge at Gwaram is a composite bridge with the deck, piers, pier caps, pile caps and abutments all made of reinforced concrete while the girders are steel I girders. On this bridge, the team observed that there was barely any form of protective barriers left. The aluminum bridge railings were all missing either due to impact damage from road accidents or vandalism. This can be seen in figure 22.

Figure 22.Noticeable absence of railings.

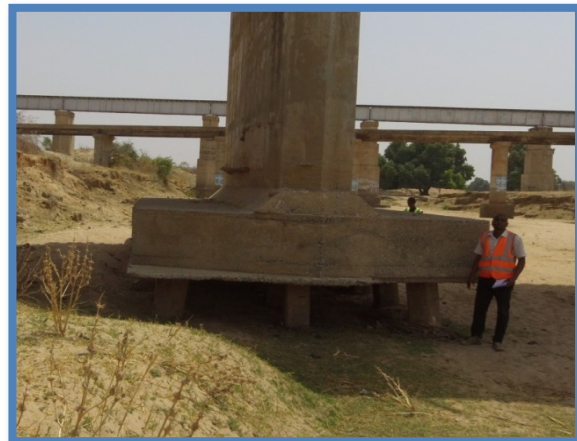
Further inspection revealed that the channel bed has undergone serious erosion and some pile caps and numerous piles have been left exposed and are undergoing weathering as seen in figure 23. The team concluded that the piers with exposed piles have reduced support capacity and pose a threat to the structural integrity of the bridge as a whole. This is a potential hazard that could result in loss of lives and property.

Figure 23.Exposed pile caps and piles

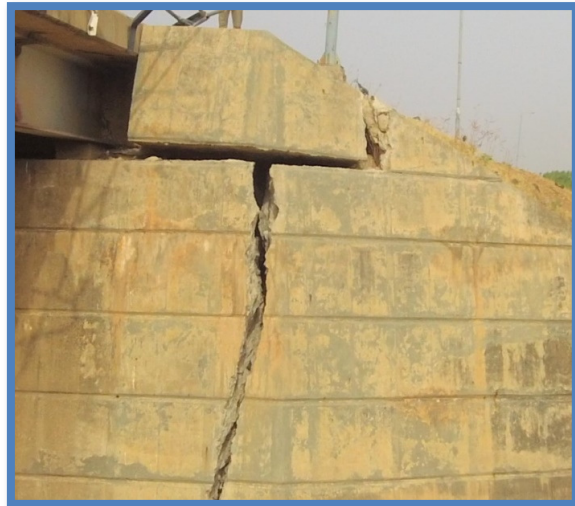
This bridge is located along Gombe-Biu road. The main construction materials are concrete and steel. It has been shut off to general traffic due to its deplorable condition. The abutment from the Gombe approach has literally broken in two directions; horizontally and vertically as seen in figure 26. The team observed that no reinforcements were used in the construction of the abutment: it was just a big mass of concrete with inadequate tensile resistance to loading. The contractor erroneously designed the abutment to be over 1 metre thick, thinking it sufficient to carry out its functions. This can be seen in figure 27.

Figure 27.Absence of rebars in abutment.
