Geotechnical investigation of pavement failure: a case study of Sango Ota-Owode expressway, Nigeria

Geotechnical Investigation of Pavement Failure: A Case Study of Sango Ota - Owode Expressway, Nigeria

Akanbi DO^{1*}, Mlanga VT², Ekpo E², Egbo GN¹

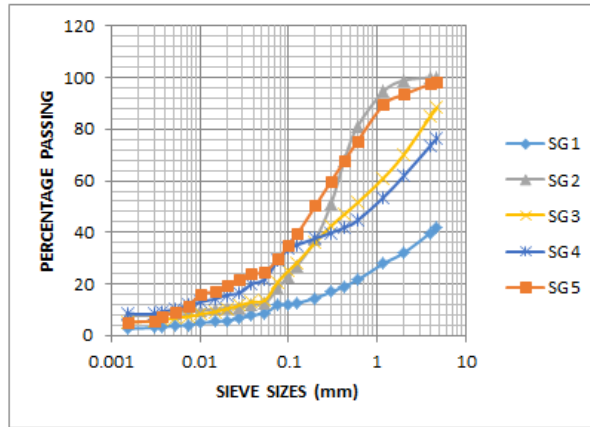
The results of the soil classification at the good sections shows that subgrade soil samples at Oja ota(Km 6+200(S-O)), Covenant(Km 10+025(S-O)), Iju(Km 12+150(S-O)), Ajibawo(Km 23+000(O-S)) and Idedo(Km 26+100(O-S)) are classified as A-2-4, A-2-4, A-2-6, A-2-4, A-2-6, respectively based on AASHTO

soil classification scheme and Sc, Sc, Sm, Sc and Sm correspondingly based on the unified soil classification system (USCS). The percentage passing sieve No.200 for all the subgrade are less than 35% implying that they are good materials.

Fig-3: Graph showing the sieve analysis of the sub grade soil samples in the good sections

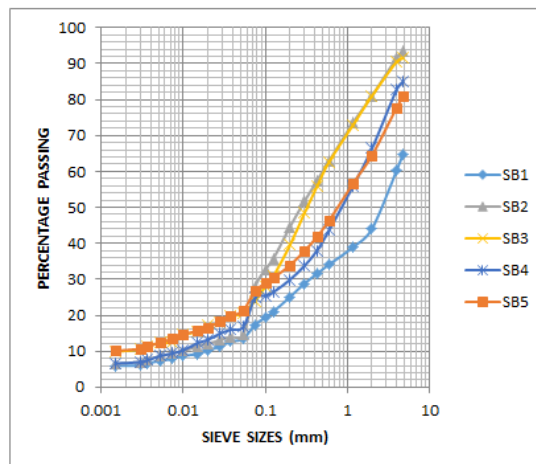
Similarly, the subbase soil samples are classified as A-2-7, A-2-4, A-2-4, A-2-6 and A-2-7 respectively, based on AASHTO classification scheme and Sm, Sc, Sc, Sm and Sm, correspondingly based on the unified soil classification system (USCS). The percentage passing sieve No.200 for all the subbase samples are satisfactory as none is greater than 35%

In relation of the good sections to the failed sections on the pavement, it can be seen that all the samples collected from the stable section met their respective criteria and are therefore good materials. Hence, the reason for their stability.

Fig-4: Graph showing the sieve analysis of the sub base soil samples in the good sections
