Geotechnical Investigation of Pavement Failure: A Case Study of Sango Ota - Owode Expressway, Nigeria

Akanbi DO^{1*}, Mlanga VT², Ekpo E², Egbo GN¹

Abstract

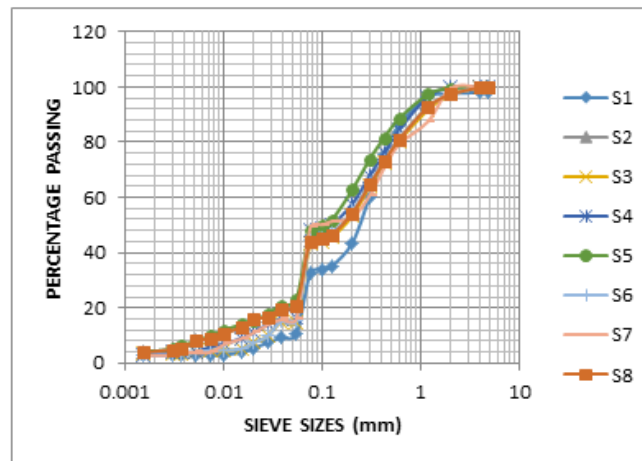
Figures 1 and 2, shows the Particle Size Distribution of the bad soil samples at Subgrade and Subbase respectively with percentage passing plotted against sieve sizes. Sango Ota- Owode lane is represented by (S-O), while Owode – Sango Ota lane is represented by (O-S). The results shows that the particle size distribution classified the subgrade samples for locations at Sango (Km 1 + 345(s-o)), Iyana Joju (kM 2 + 050 (s-o)), Oju ore (kM 28+ 100 (o-s)), Honda (kM 25+ 069(o-s)), Iyana Iyesi (Km 24 + 000 (o-s)), Igboloye (Km 19 + 300 (o-s)), Atan (kM 20 + 150 (s-o)) and Owode (Km 31 +100 (s-o)) as A-2-4, A-2-6,

A-2-6, A-2-7, A-2-7, A-2-7, A-2-6 and A-2-7, respectively based on AASHTO soil classification scheme, and Sc, Sm, Sc, Sc, Sc, Cl, Sm and Cl, correspondingly based on the Unified Soil Classification System (USCS). The Percentage passing sieve No.200 for all subgrade samples except sample 1, collected at Km 1+345 are greater than 35%, implying that they are poor materials. The subgrade samples cannot therefore, be recommended for new repairs. As a result, they need to be completely removed and replaced with better materials for construction. Also, a strong stabilization material may be applied in the subgrade soils to improve their performance.

Fig-1: Graph showing the sieve analysis of the sub grade soil samples in the bad sections

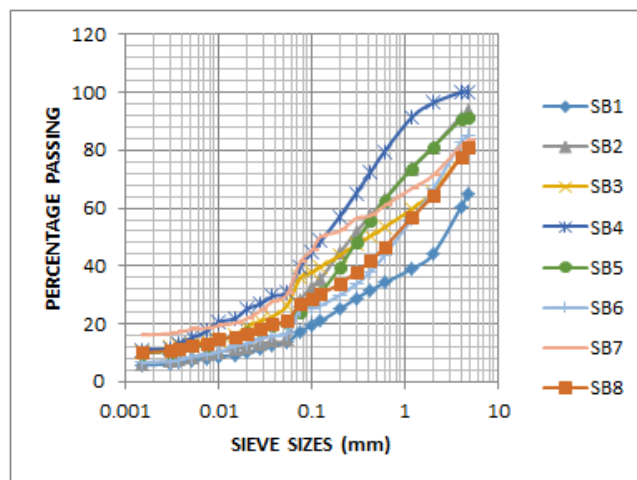
Similarly, the particle size distribution results for the subbase samples for locations at Sango (Km 1 + 345(s-o)), Iyana Joju (kM 2 + 050 (s-o)), Oju ore (kM 28+ 100 (o-s)), Honda (kM 25+ 069(o-s)), Iyana Iyesi (Km 24 + 000 (o-s)), Igboloye (Km 19 + 300 (o-s)), Atan (kM 20 + 150 (s-o)) and Owode (Km 31 +100 (s-o)) are classified as A-2-6, A-2-7, A-2-7, A-7-5, A-2-7, A-2-6, A-2-7 and A-2-6, respectively based on AASHTO classification scheme and Sm, Sm, Sm, Sm,

Sm, Sc, Sm and Sm, correspondingly based on the Unified Soil Classification System (USCS). The Percentage passing sieve No.200 for all subbase samples except samples 3, 4 and 7, which are 35.87%, 39.74% and 41.31%, respectively, are less than 35% specified for percentage passing sieve No. 200, implying that the samples at these locations need to be removed and replaced or stabilized with a strong additive.

Fig-2: Graph showing the sieve analysis of the sub base soil samples in the bad sections

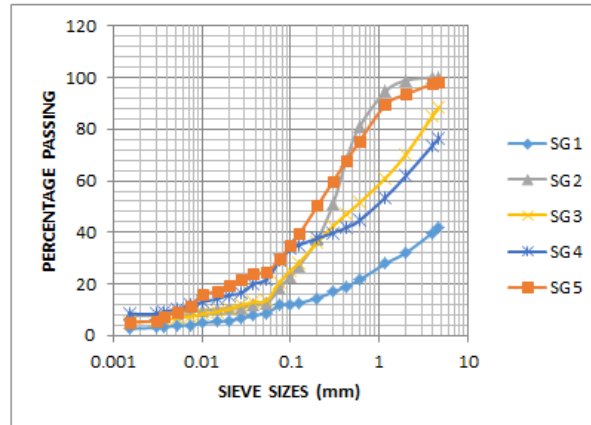
The results of the soil classification at the good sections shows that subgrade soil samples at Oja ota(Km 6+200(S-O)), Covenant(Km 10+025(S-O)), Iju(Km 12+150(S-O)), Ajibawo(Km 23+000(O-S)) and Idedo(Km 26+100(O-S)) are classified as A-2-4, A-2-4, A-2-6, A-2-4, A-2-6, respectively based on AASHTO

soil classification scheme and Sc, Sc, Sm, Sc and Sm correspondingly based on the unified soil classification system (USCS). The percentage passing sieve No.200 for all the subgrade are less than 35% implying that they are good materials.

Fig-3: Graph showing the sieve analysis of the sub grade soil samples in the good sections

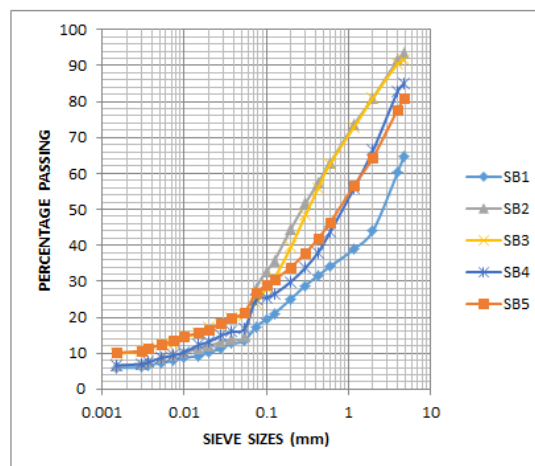
Similarly, the subbase soil samples are classified as A-2-7, A-2-4, A-2-4, A-2-6 and A-2-7 respectively, based on AASHTO classification scheme and Sm, Sc, Sc, Sm and Sm, correspondingly based on the unified soil classification system (USCS). The percentage passing sieve No.200 for all the subbase samples are satisfactory as none is greater than 35%

In relation of the good sections to the failed sections on the pavement, it can be seen that all the samples collected from the stable section met their respective criteria and are therefore good materials. Hence, the reason for their stability.

Fig-4: Graph showing the sieve analysis of the sub base soil samples in the good sections
