## The Roman fortlet or defended watch-tower/*pharos* at St John the Baptist, Reedham, Norfolk and the Early Medieval origins of the church

Michael Fulford, Amanda Clarke, Emma Durham, Sara Machin, Nicholas Pankhurst, Rob Fry, David Thornley & Rory Williams-Burrell

### ABSTRACT

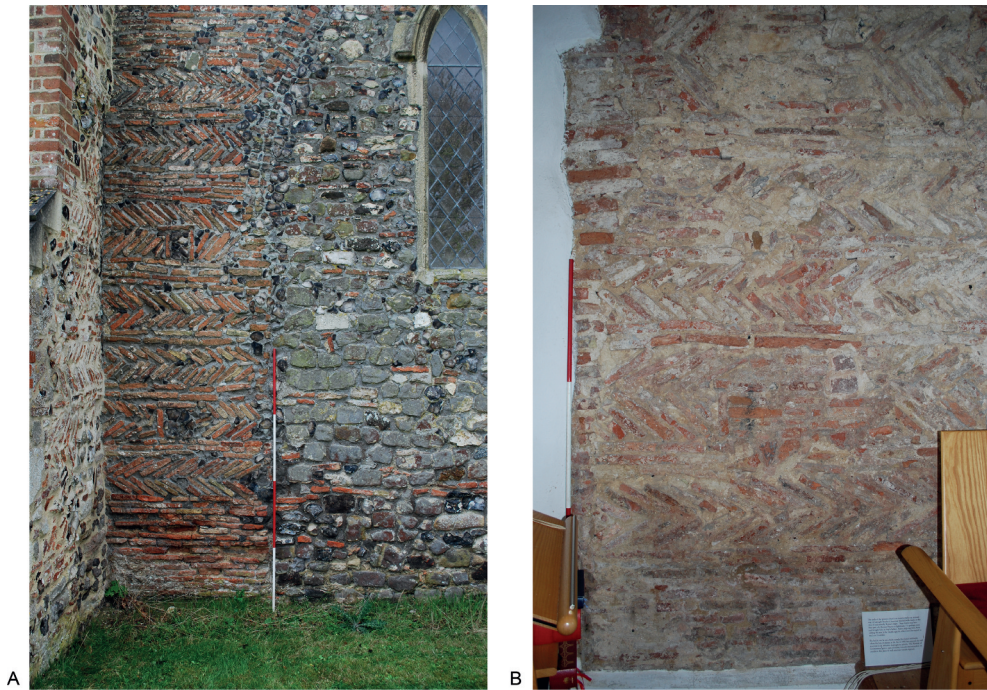
**Figure 3.** St John the Baptist, Reedham: (A) re-used Roman brick and tile at the east end of the nave on the north side; (B) internal elevation of (A): re-used Roman brick and tile at the east end of the north wall of the nave.

main body of the church is therefore built almost entirely out of re-used Roman building materials.

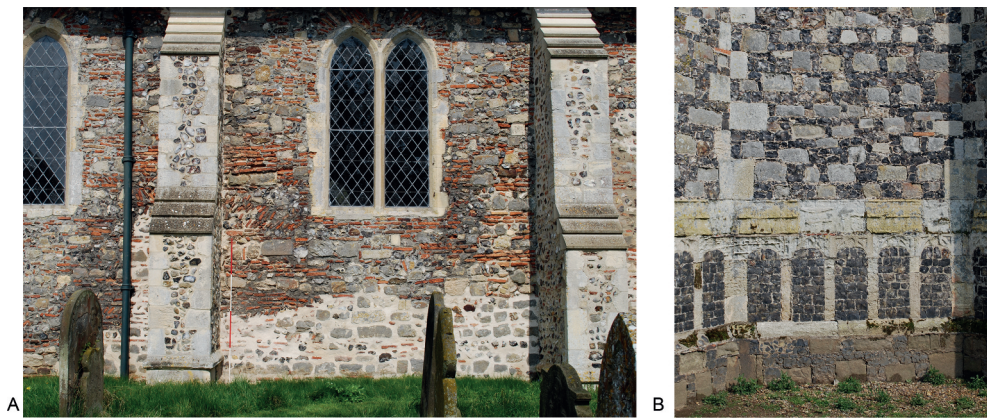
**Figure 4.** St John the Baptist, Reedham: (A) south wall of the nave with a mix of grey quartzite and Roman brick and tile; (B) south side of the tower, grey quartzite blocks and flint.

Further research on the materials used in the construction of successive phases of the church has demonstrated that the abundant grey quartzite stone can be provenanced to the Leziat Bed which contributes to a narrow outcrop of Lower Cretaceous rocks overlooking the shores of the Wash in the Hunstanton-King's Lynn-Downham Market area at a distance by sea from Reedham of some 130 km (Allen, Rose, and Fulford 2003) (Figure 1). Since the stone used at Reedham is the same as the facing stones used in the construction of the Roman fort at Brancaster, it has been argued that the fort and whatever the building was from which the church of St John the Baptist was built were contemporary and of late second/mid-third-century date (Allen, Rose, and Fulford 2003, 138). Given the distance that the stone used at Reedham was transported, it has also been suggested that the Roman building had an official, probably a military function (Allen, Rose, and Fulford 2003, 138). It should also be noted that the grey quartzite used in the Roman structure at or near Reedham is quite different from the stone, predominantly flint, used in the defences of the nearby coastal forts of Caister-on-Sea and Burgh Castle and the *civitas* capital at Caistor-by-Norwich. Beside the distinctive stone, Roman brick and tile are also abundant in the fabric of the nave and chancel of the church.

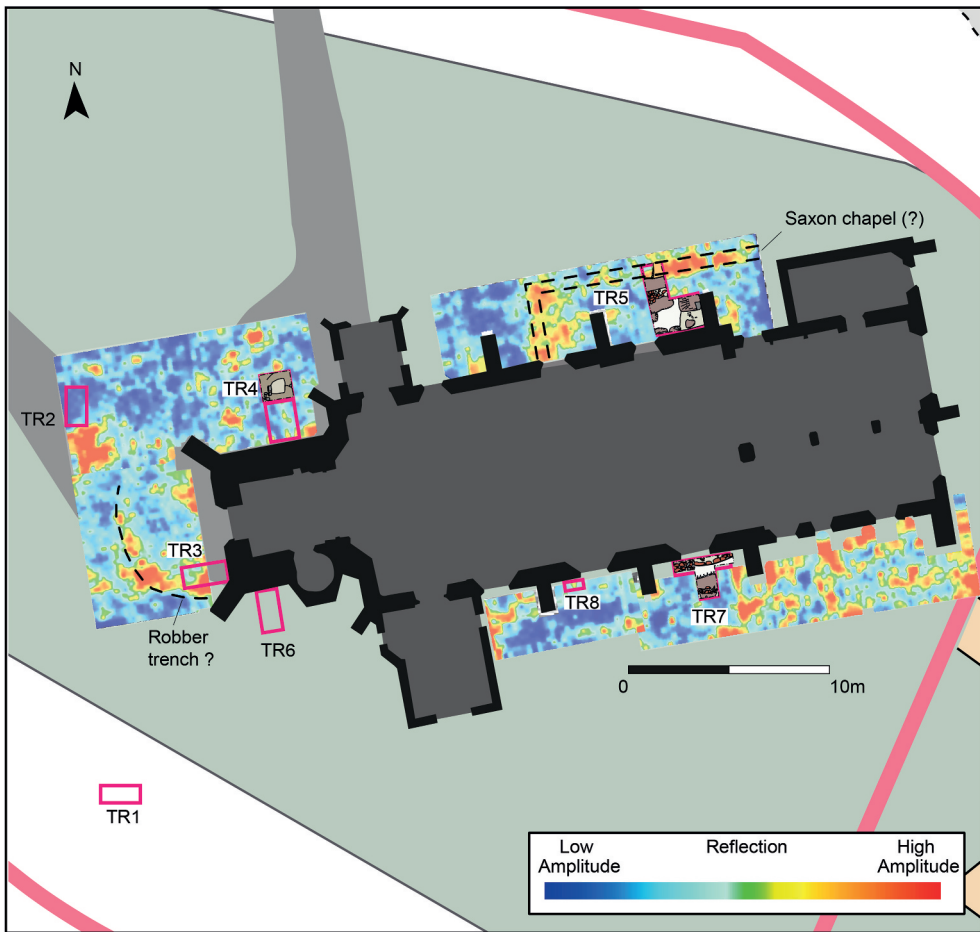
**Figure 7.** Ground-penetrating radar survey of the exterior of the church of St John the Baptist, Reedham at a depth of 0.4 m using a 900 MHz antenna and showing the location of the excavation trenches.

Two further areas of interest were found to the west and south of the church tower at a depth of 1.5 m with the 400 MHz survey (Trenches 1 and 2 on Figure 7). In the latter area reflectors defined a rectangular feature measuring some 10 m by 8 m with a central void.

of white mortar or plaster and traces of a further lens can be seen c. 5 cm higher in the section. This structure coincides with the position of the east–west-aligned linear feature of high reflectance from the 900 MHz GPR survey (Figure 7).

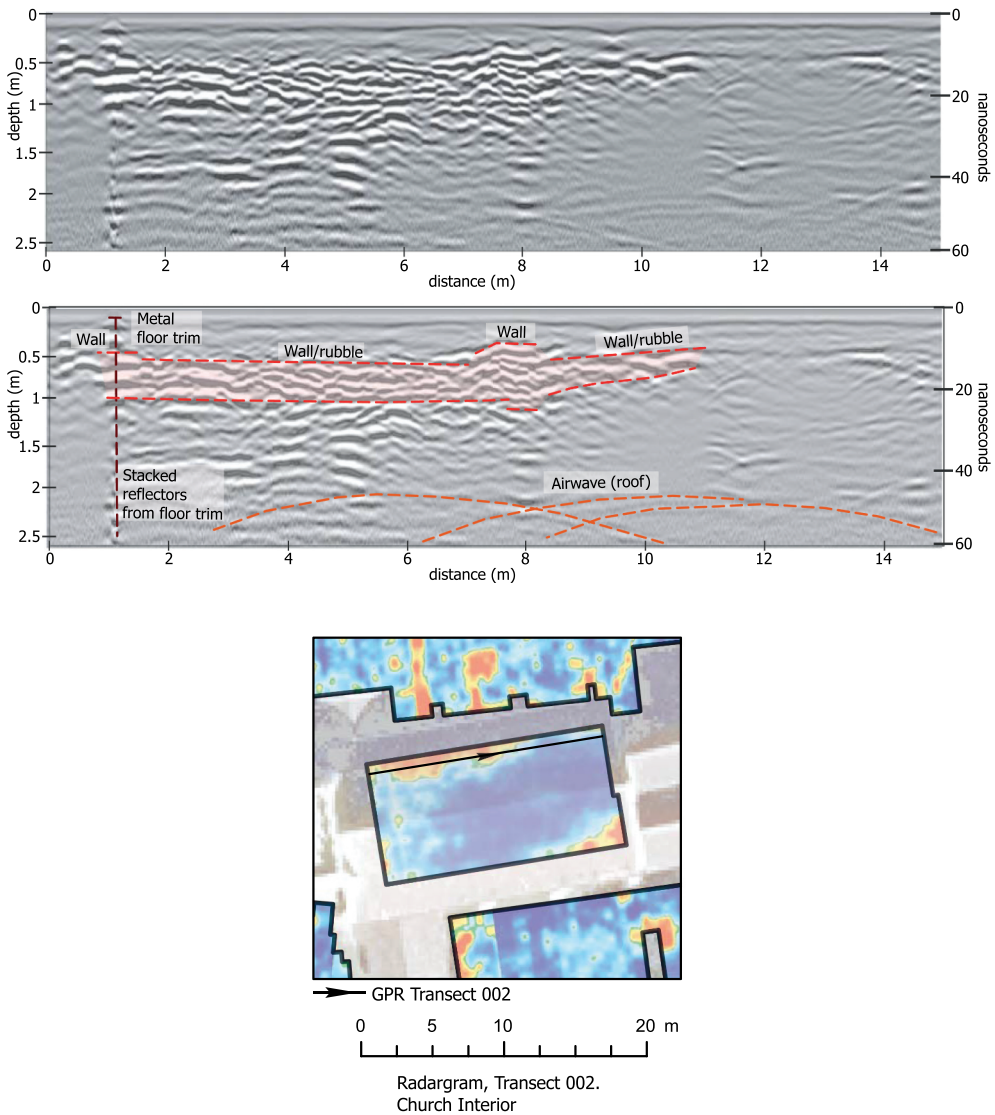
**Figure 8.** Selected radargram of the nave survey, E–W transect showing a cross-section of the wall/levelling deposits.

Strong reflectance anomalies were recorded at a depth of 0.7 m along the north and south side of the nave (see profile image, Figure 8). On the north side the buried feature is 2 m wide at the west end, gradually thinning out some 7 m to the east. On the south side the feature is also about 2 m wide at the east end, gradually thinning out some 7 m to the west. The features are approximately parallel with one another but not parallel with the extant walls of the nave, deviating from them by about 10°. The strong reflectance of this feature within the data suggests they could be potential wall features and levelling and/or rubble deposits which extend to a depth of just over a metre beneath the ground surface. The strong reflectors on the south side continue into the chancel. Strong reflectors were also recorded next to the altar, but these coincide with monumental grave slabs and are probably to be attributed to the burials.

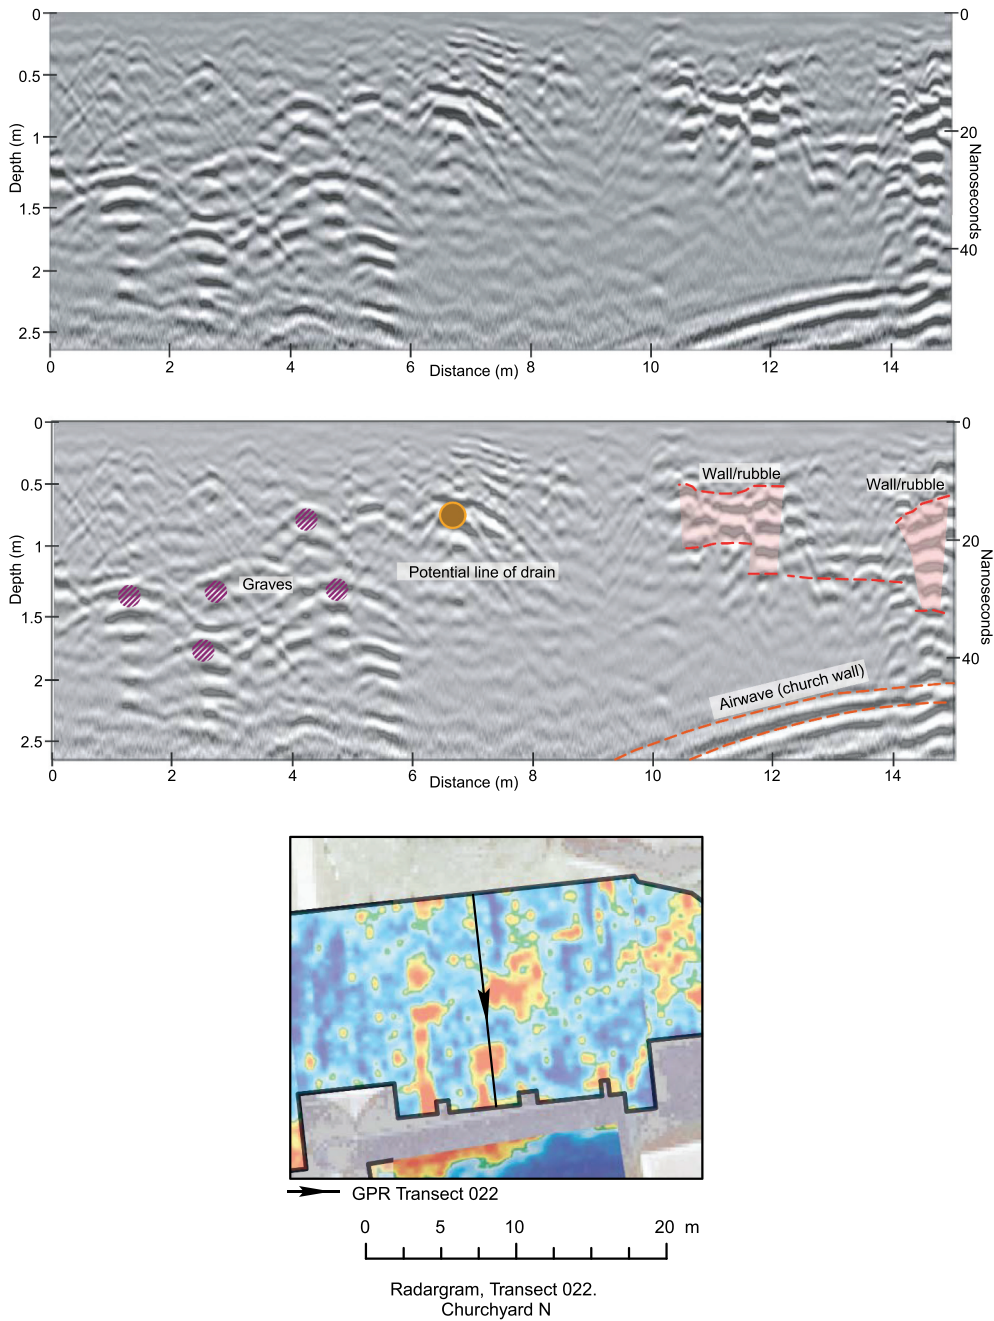
**Figure 9.** Selected radargram of a N-S transect across the north side of the churchyard, to the north of the nave, crossing graves, a drain and possible wall feature.

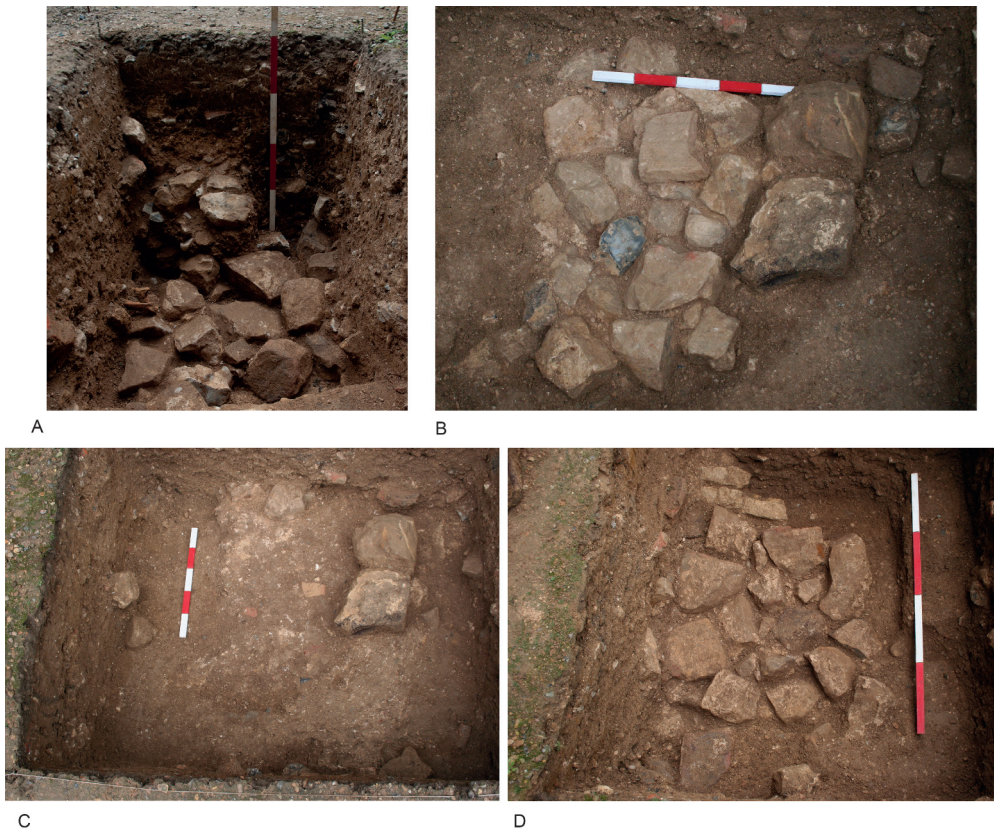
**Figure 10.** Trench 4: (A) collapsed rubble layer [4013], view to north, 2017 (scale: 1 m); (B) rubble [4021] and quartzite facing blocks below [4019] (Figure 11), view to south, 2018 (scale: 0.5 m); (C) mortar-rich layer [4022] below [4021] (B), view to south, 2018 (scale: 1 m); (D) rubble [4023] below [4022], view to west, 2018 (scale: 1 m).

area (1 m by 0.6 m) of blocks of unworked grey quartzite set on a yellow-cream mortar [4014] was found in 2017 at a depth of 0.4 m (Figure 10(A)). The trench was extended the following year a further 1.2 m to the north, revealing more of the yellow-cream mortar spread over an area of 1 m by 0.45 m (Figure 11). With a thickness of 0.04–0.06 m, it was edged to the west by two blocks of the grey quartzite, each roughly dressed on their west-facing face. This was all that remained of the lowest course of masonry. Beneath the mortar layer were the foundations: roughly coursed, unworked blocks of stone with length measurements of 0.2–0.6 m (Figure 10(B)) and beneath that a further spread of mortar [4019] (Figure 10(C)), sealing a further layer of rubble [4021] (Figure 10(D)). The rubble extended deeper still to a depth of >2 m below the present

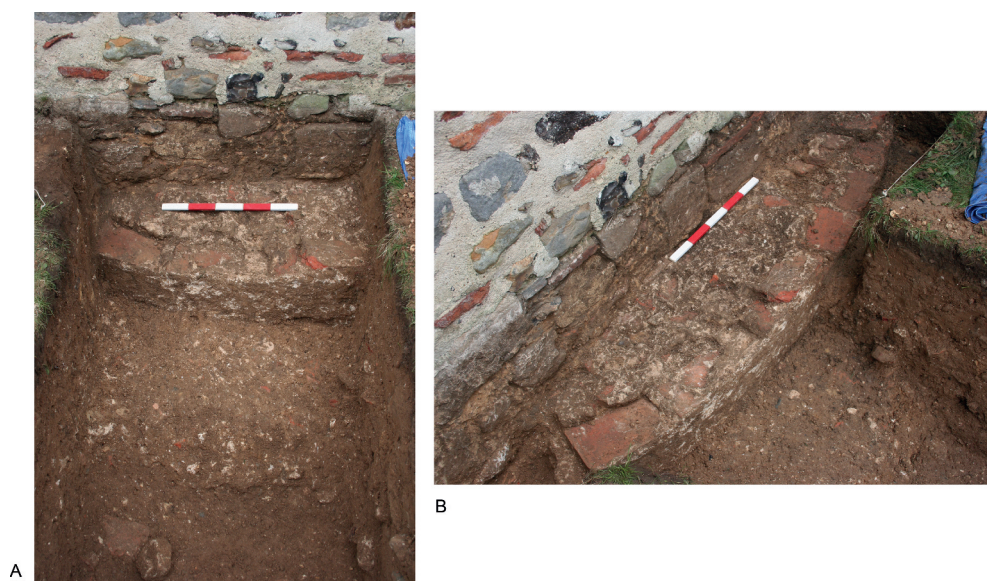
**Figure 13.** Trench 7: Roman masonry of grey quartzite and Roman brick [7020] viewed (A) from the south, (B) from above (scales: 0.5 m).

nave wall. It consists of a core of grey quartzite rubble and broken tile in a hard cream mortar faced with the remains of three courses of Roman brick sealing two courses of dressed grey quartzite, largely concealed by a skin of pale cream plaster. Beneath the coursed masonry which survived to a height of 0.4 m were traces of broken tile and mortar foundations [7008]. Against the wall was a mixed context of clay, mortar and tile fragments [7009] which proved to be the fill of a grave cut, which was itself cut by

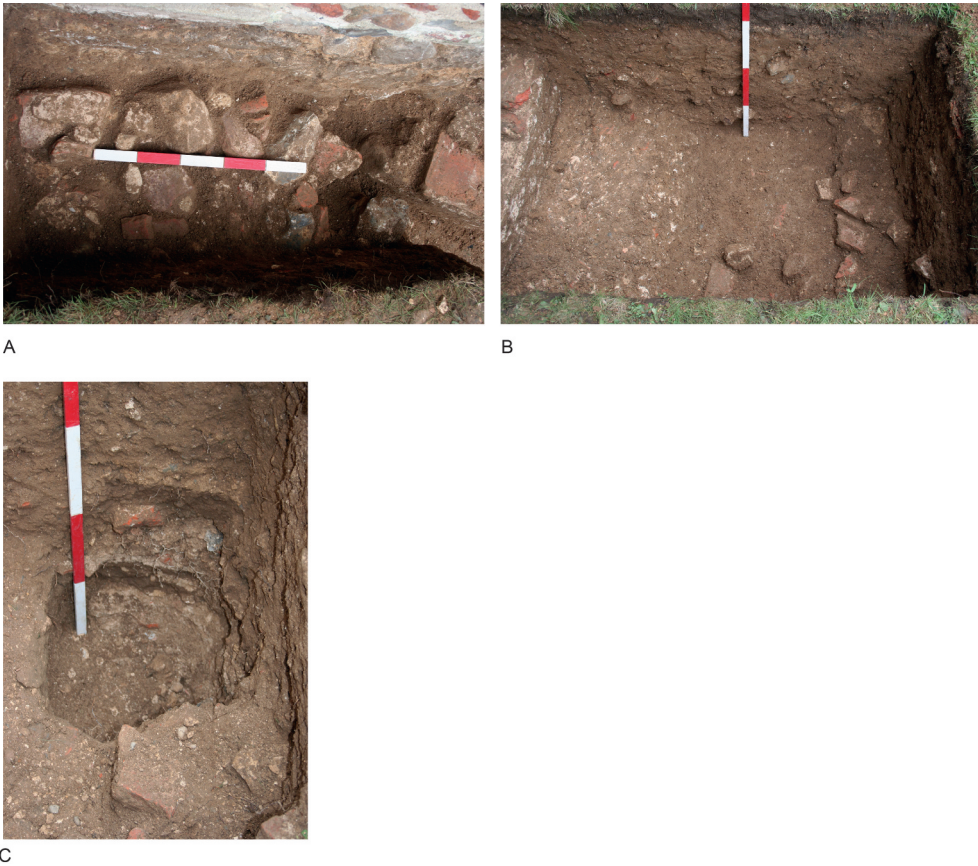
**Figure 14.** Trench 7: (A) unmortared rubble [7008] parallel with the south wall of the nave west of Roman masonry (scale: 0.5 m); (B) weakly mortared structure of Roman brick and tile at the south end of the trench from the west [7003] (scale: 0.20 m); (C) profile of tiled feature showing mortared deposits interleaved with deposits of brown soil [7003, 7010, 7013, 7012] (scale: divisions of 0.20 m).

A second mortared structure, in this case only of Roman brick and tile, at least 0.3 m wide, was discovered 1.2 m south of the Roman masonry, 1.6 m from the wall of the nave, at a depth of 1.25 m (Figures 12 and 14(B–C)). It was not possible to explore its full extent to the south and it had been cut by a grave on its northern side. Above the solid structure [7012] was a layer of brown soil, 0.15 m thick, and above that was a 0.4 m-thick deposit of crumbly mortar, Roman tile and flint [7010], above which was a thin layer of crumbly mortar and broken Roman tile [7003].

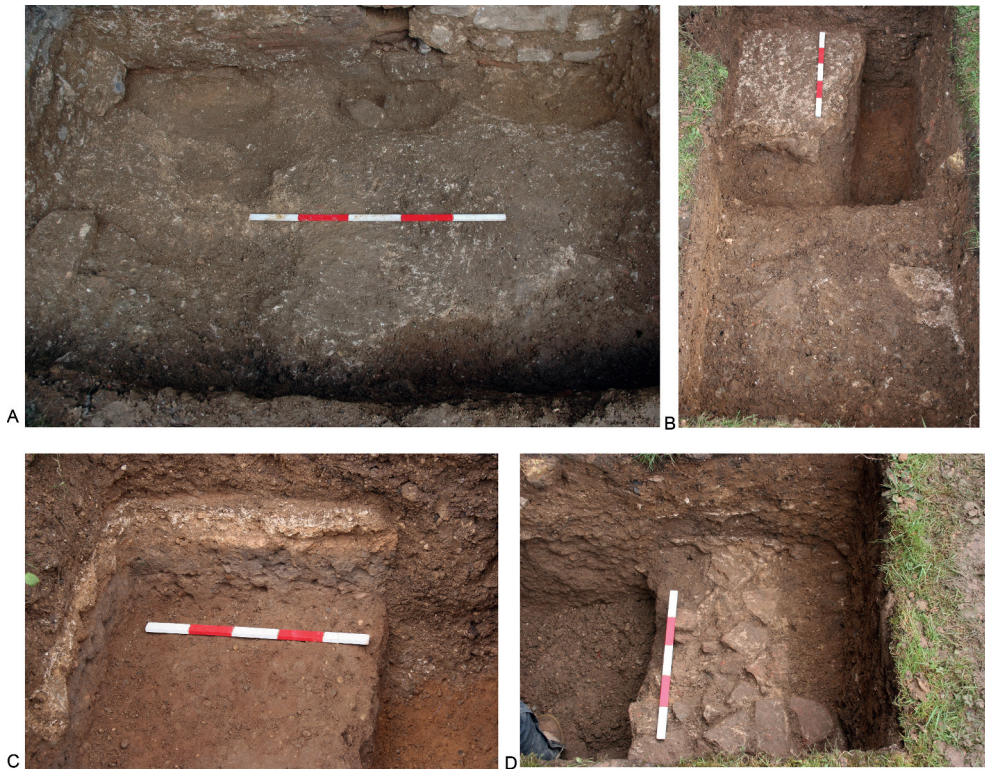
**Figure 16.** Trench 5: (A) view to south showing the mortared surface in 2017, plastered base of brick-built nave wall and cut in the wall for flue of nineteenth/twentieth-century stove (scale: 1 m); (B) a further area of hard mortar in 2018 (scale: 0.5 m); (C) mortar layer in profile 2018 (scale: 0.5 m); (D) foundation of re-used Roman brick in a crumbly mortar at north end of trench (2018) (scale: 0.5 m).

Trench 5 was located directly opposite Trench 7 against the east end of the north wall of the nave, positioned to see if any trace could be found of whatever structure was causing the line of high radar reflectance along the inside of the north wall of the nave. The trench straddled the junction between the nave wall built entirely of re-used Roman brick and the blocked arch of c. 1300 (Figures 3, 15 and 16). The excavation exposed the base of the nave wall which, in the case of the brick-built section, was covered with a white plaster. The original 2 m by 1 m trench proved to be opposite the disturbance created by the flue of a modern boiler and, to compensate, was extended east to the adjacent buttress. Altogether it measured 2.4 m (E-W) by 2.6 m (N-S). Although the trench was badly disturbed by grave cuts, remains of a layer of creamy-coloured mortar [5005, 5009, 5011], <0.1 m thick, was found at a depth of 0.45 m, corresponding with the exposed base of the nave wall (Figures 15 and 16(A)). The condition of the mortar was variable: quite compact in the centre and west, crumbly and yellow to the east. With a 2–6 mm gravel matrix, it contained pieces of Roman brick or tile, <0.1 m in length, and pieces of grey quartzite of similar size. Associated with [5005] were six body sherds of Late Saxon, tenth-century jars, including two sherds of Ipswich ware, a sherd of St Neots ware and three unattributed unglazed sherds, all identified by Alice Lyons. Except for a 1.0 m-wide strip along the east-facing section, the mortared surface was left undisturbed. Beneath the mortar was the natural sand [5012]. Charcoal from a sample taken at the interface of mortar and natural (indicated on Figure 15) provided two radiocarbon dates from, respectively, juvenile *Quercus* and juvenile *Betula* charcoal:  $1305 \pm 34$  BP = 656–770 cal AD at 95.4% probability (SUERC-75101) and  $1330 \pm 33$  = 647–768 cal AD at 95.4% probability (SUERC-75100). In 2018 the trench was extended 2 m by 1 m northwards, the west edge a continuation of the west edge of the 2017 trench. At the north end at a depth of 0.5 m and cut by graves on both sides, was a further area of hard white mortar similar to that found in 2017 [5011] (Figure 16(B and C)). Between it and the north edge of the 2017 trench at a depth of c. 0.45 m was a possible foundation of re-used Roman brick laid flat in a light brown sandy clay and mortar [5019, 5020] and appearing to be aligned east-west (Figures 15 and 16(D)). It was sealed by a thin lens

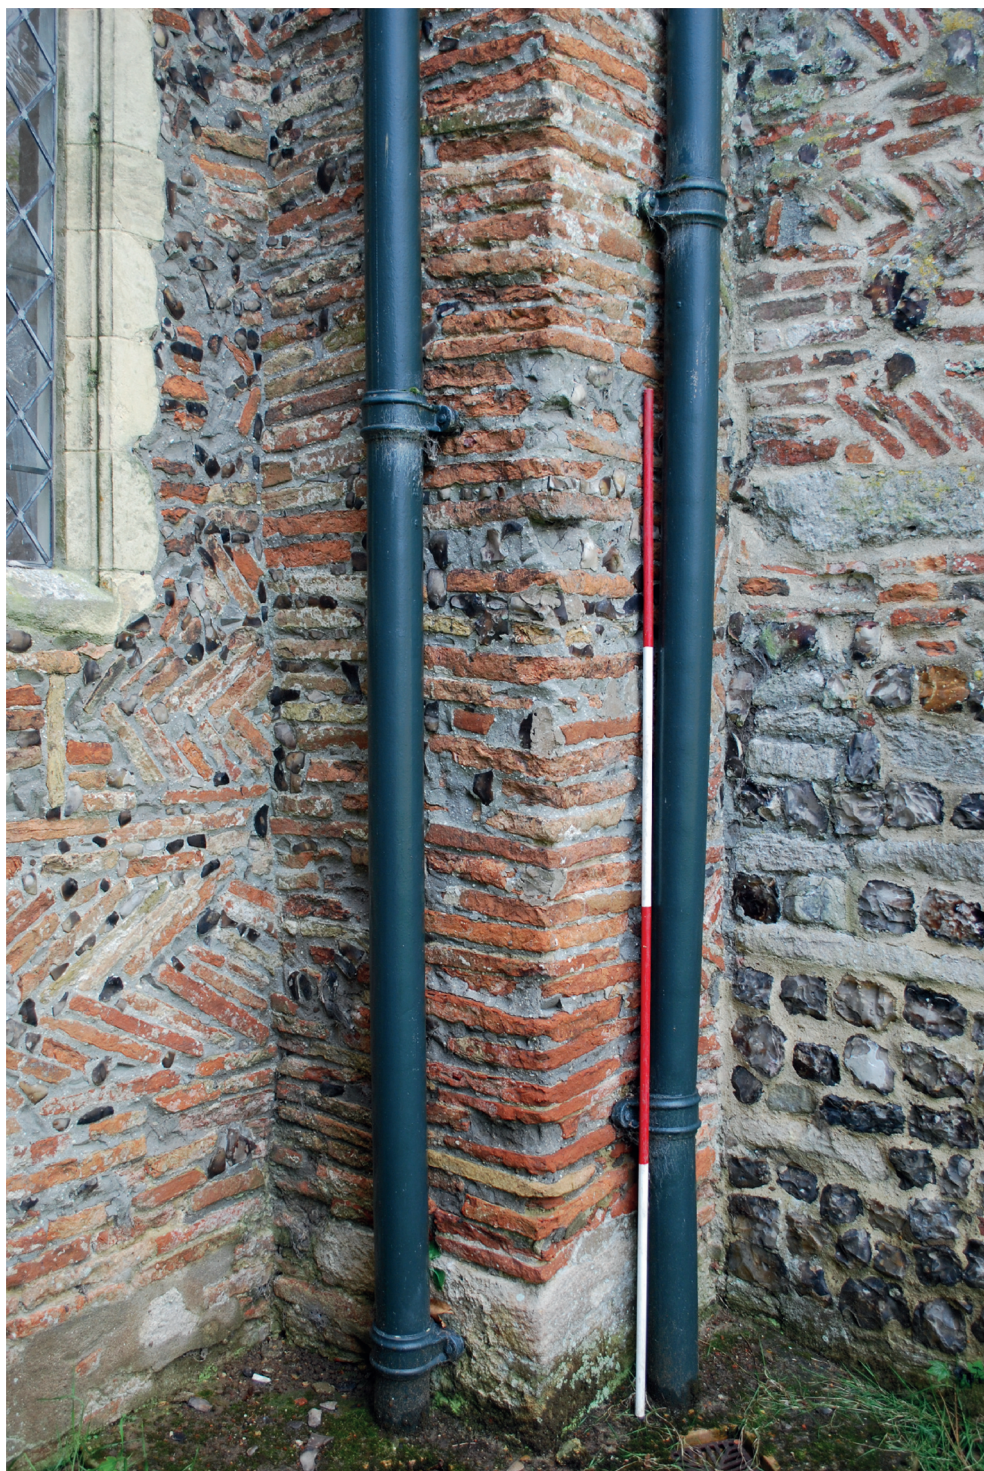
**Figure 17.** North-east corner of nave with quoining of re-used Roman brick and tile.

Next to the easternmost and later buttress of the present church is quoining of horizontally laid brick or tile above a basal block of grey quartzite, together standing to a height of 6.3 m (the top metre or so perhaps re-built) (Figure 17). This is suggestive of an original east end of the brick-built church, giving the nave an approximate east–west length of 6.5 m. This would suggest a small church, more comparable with St Martin’s, Canterbury, whose original nave was c. 6 m in length, than with the other early Canterbury churches (below). Butted against the quoins to form the north wall of the present chancel, the same style of build of herringbone alternating with horizontally laid brick or tile continues east for a further 2.1 m with good preservation below the later chancel window. It is possible that the brickwork ends at the point where it might have turned to form the apse of the Early Medieval church.

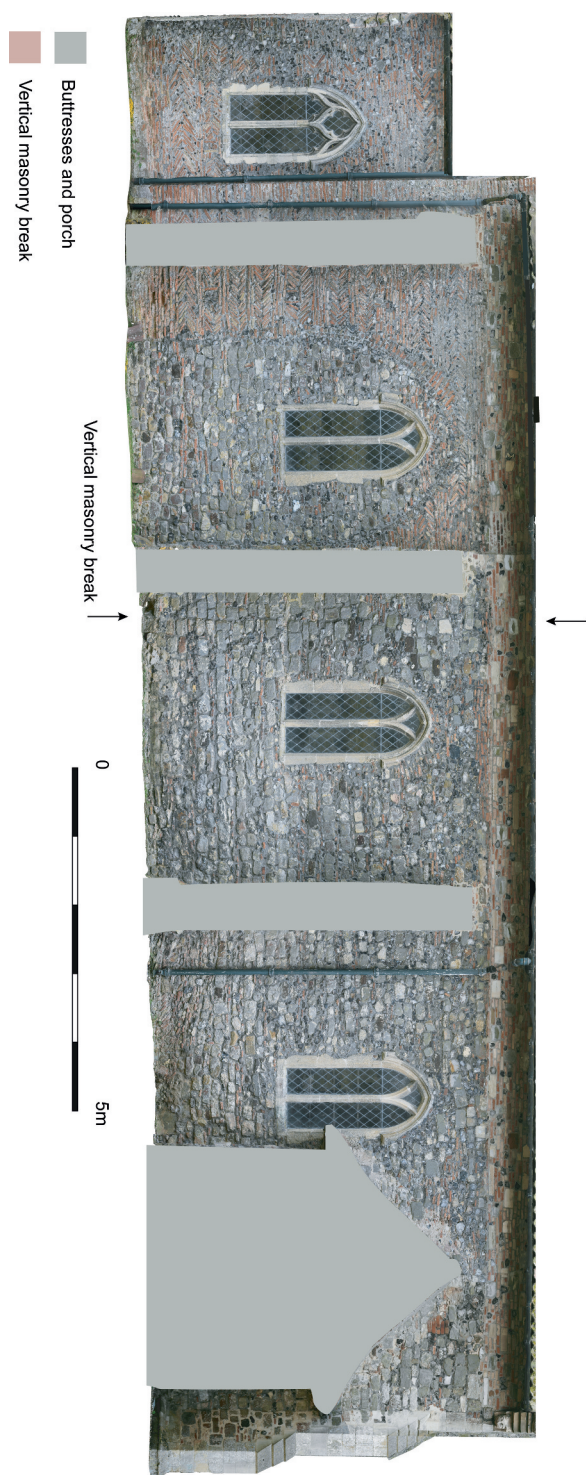
**Figure 18.** Rectified photograph of the north wall of the nave of St John the Baptist; arrows indicate the break in masonry west of the central buttress.

The feature defined by the GPR extends a little further west beyond the central buttress and the end of the surviving brick-built wall and also beyond a vertical join visible externally just west of the central buttress (Figure 18). This join was also recorded internally by Rose before the replastering of the interior following the 1981 fire and so no longer visible today (1994, 4, pl. IA, reproduced here as Figure 19). This image also shows a second vertical join, approximately 0.3–0.4 m to the east of that visible externally, but its outer face is concealed by the central buttress. The material abutting the now concealed join is grey quartzite, the blocks interpreted by Rose as quoins which rise to the full height of the nave wall. Towards the base they appear to be of one build with the brick fabric and may therefore possibly represent the west end of the brick-built structure, though the west end of the GPR-defined *porticus* feature extends a little further west. To the east the feature defined by the GPR more or less coincides with the furthest surviving eastward extent of the brick-built wall. The blocked archway in the north wall of the nave is approximately central to the GPR-defined feature. It indicates that the Early Medieval structure still stood and formed an integral part of the build of the 1200s but was presumably demolished at the time of the blocking which took place a century or so later. The function of the narrow strip of walling between the two joins is unclear – remains of a buttress against the north-west corner of the brick-built church or the stub of a north–south wall?

**The brick-built structure:** What is remarkable about the surviving brick-built section of the north wall of the nave is that it is composed entirely of re-used Roman brick and tile, unlike the rest of the north wall which is built very largely of re-used grey quartzite blocks with only a very small amount of brick scattered through the fabric. Re-used Roman brick is more common in the fabric of the south wall of the nave, but used horizontally in random fashion (Figure 4). If we assume that this material was employed consistently throughout the Early Medieval structure, as the surviving fragment suggests, it implies a very considerable scale of robbing of the Roman building where it would have been used as string coursing or decoratively, as we see in the surviving fragment of the Roman build in Trench 7. Here, the remains of three courses of facing brick seal the dressed grey quartzite blocks below. Bricks used in this way or as string courses through the full width of the wall are a distinctive and common feature of

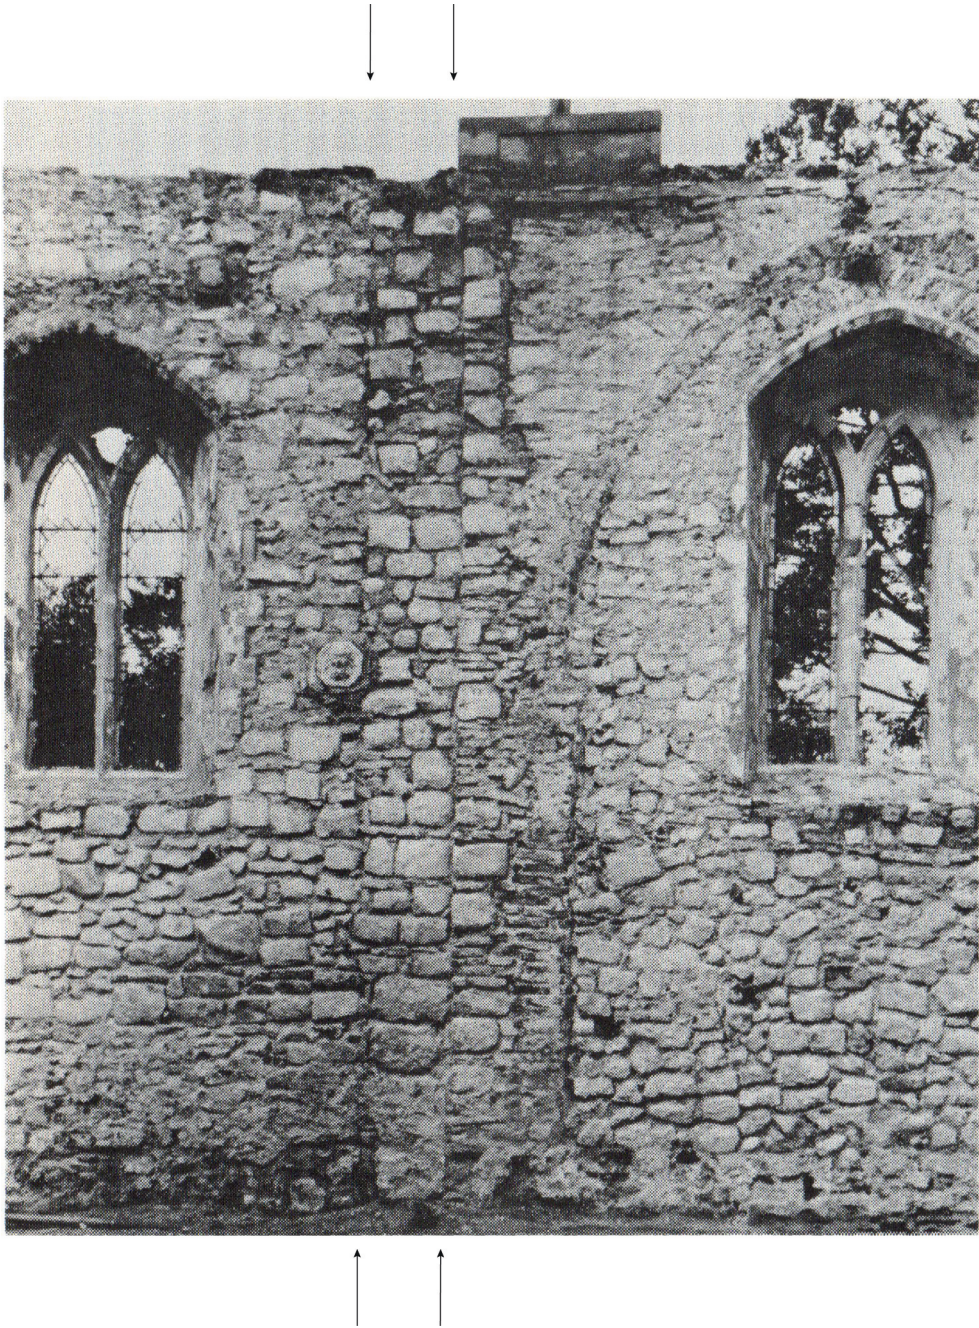
**Figure 19.** Interior view of the north wall of the nave (Rose 1994, pl. 1A, reproduced by kind permission of the British Archaeological Association). The arrows indicate the vertical joints in the nave wall.

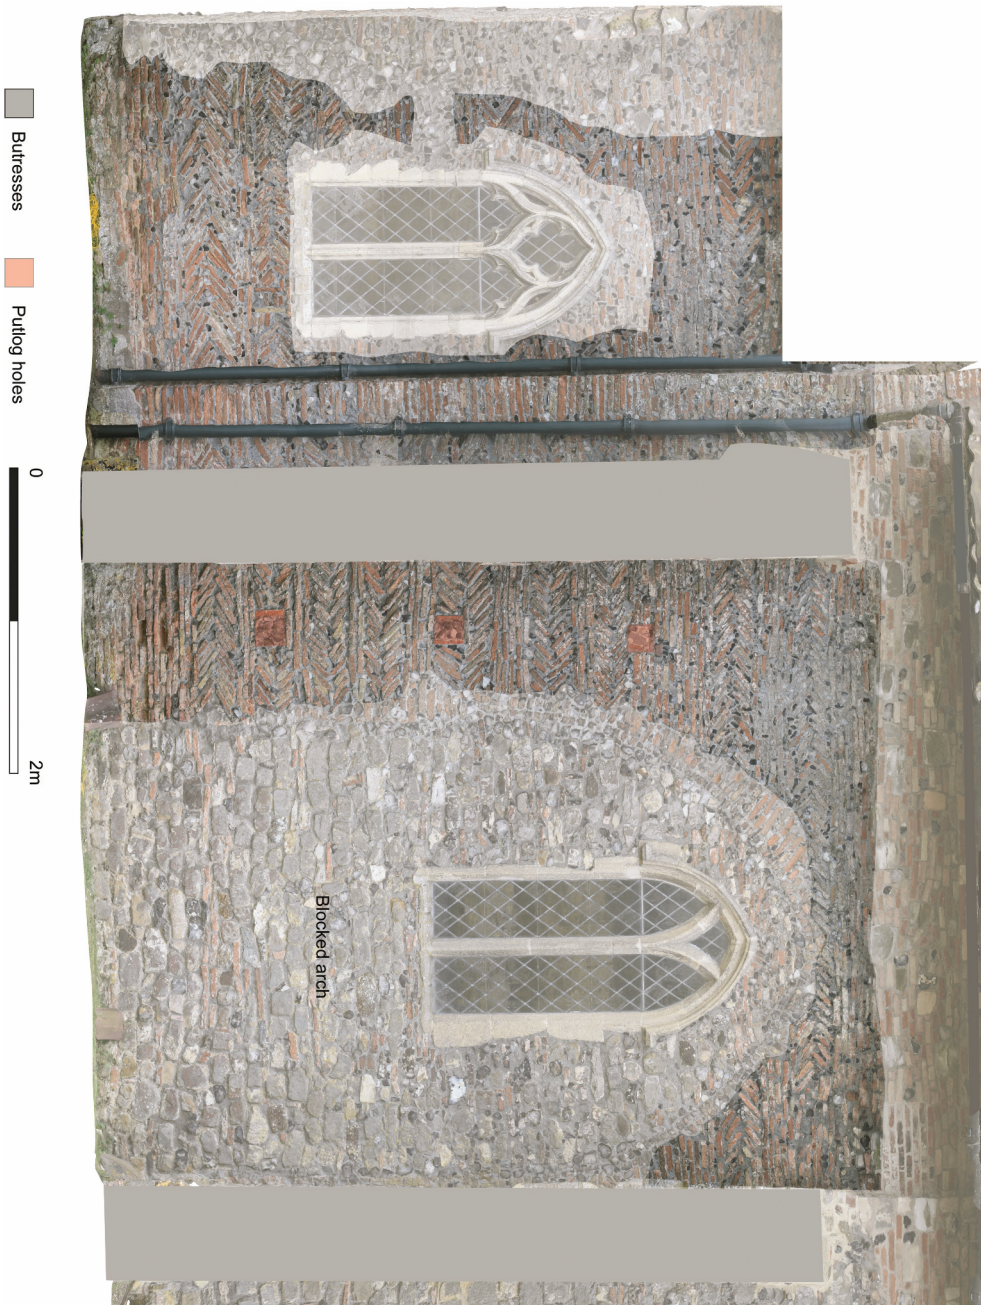
**Figure 20.** Rectified photograph of the brick-built north wall of the nave with the later, blocked arch highlighted.

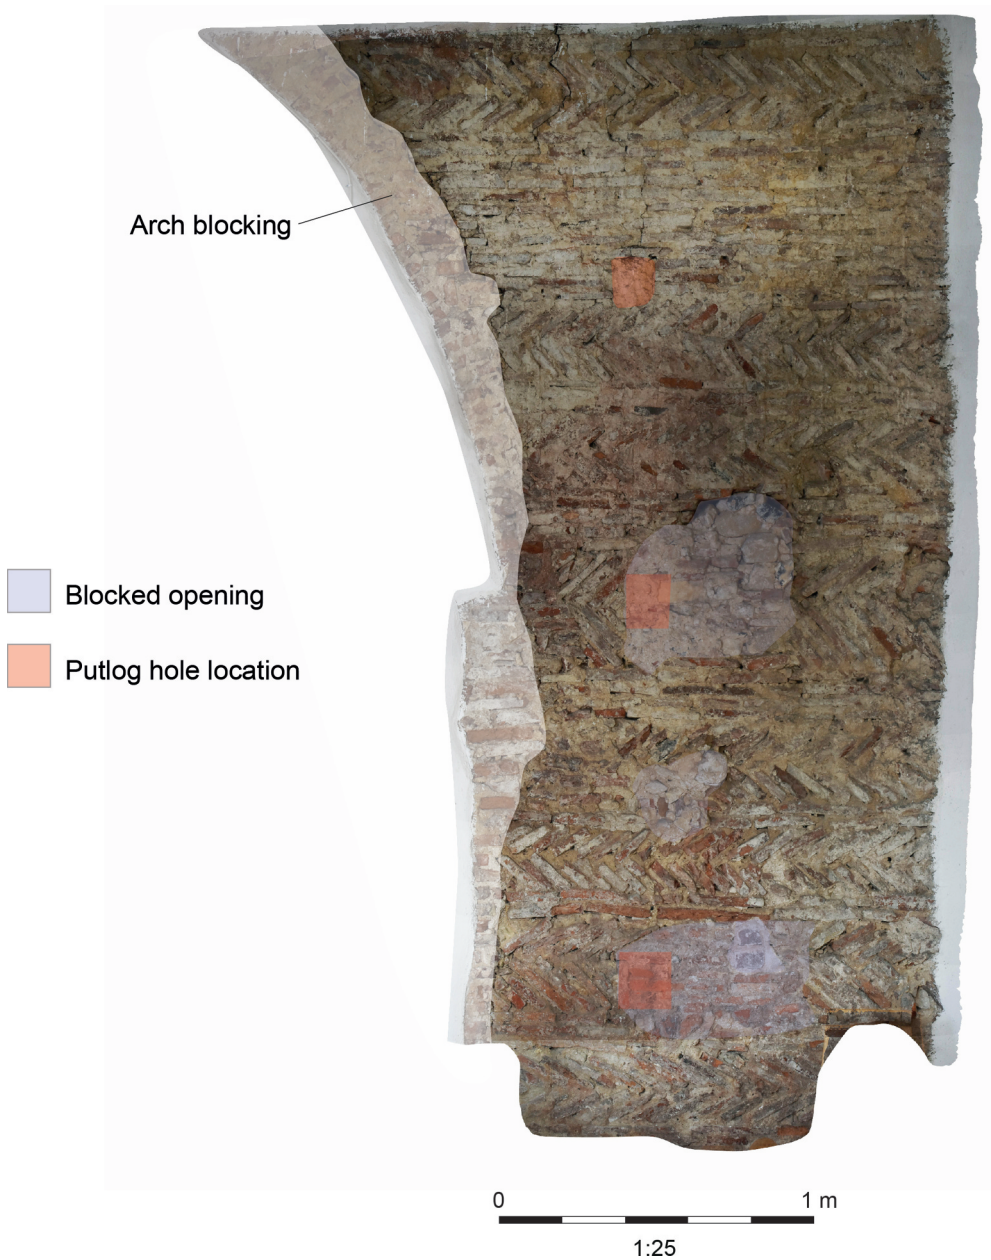
**Figure 21.** Rectified photograph of internal elevation of brick-built north wall of the nave.

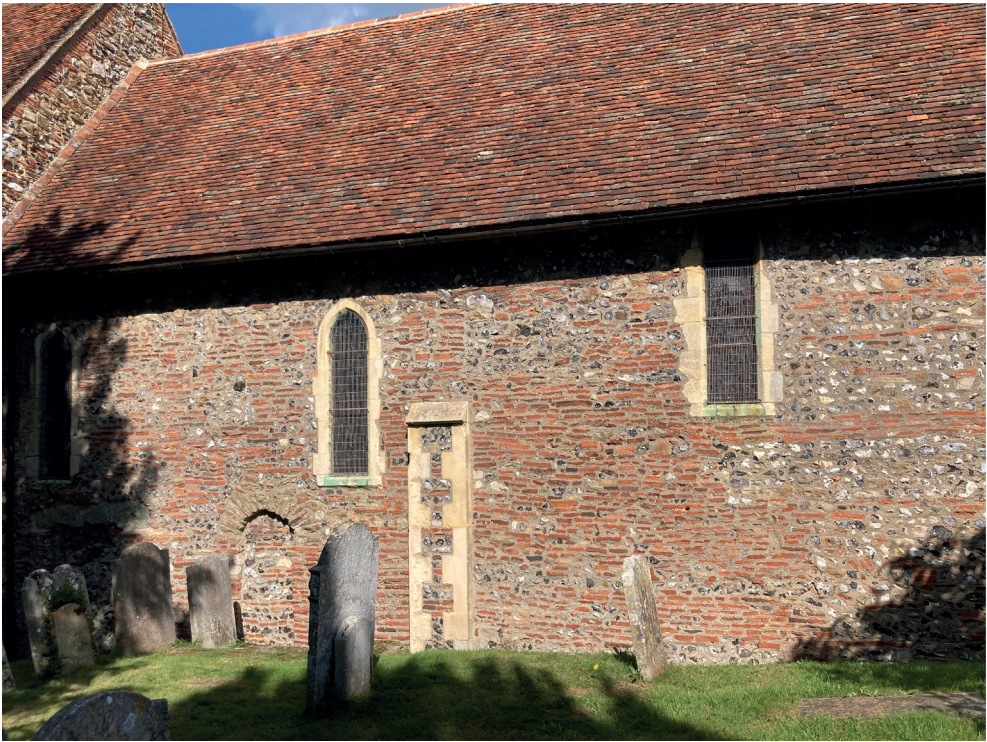
**Figure 22.** The north wall of the chancel, originally the nave, of St Martin's, Canterbury.

church. The better-preserved south wall of the chancel, formerly the nave of the earliest church, is built of well-laid Roman brick and tile in horizontal, but slightly undulating courses, as are the pilasters or buttresses (Figure 22). There is also flint, possibly added in later restorations, interspersed among the brick and tile. A later addition at the east end where courses of flint are interspersed with courses of Roman tile more closely

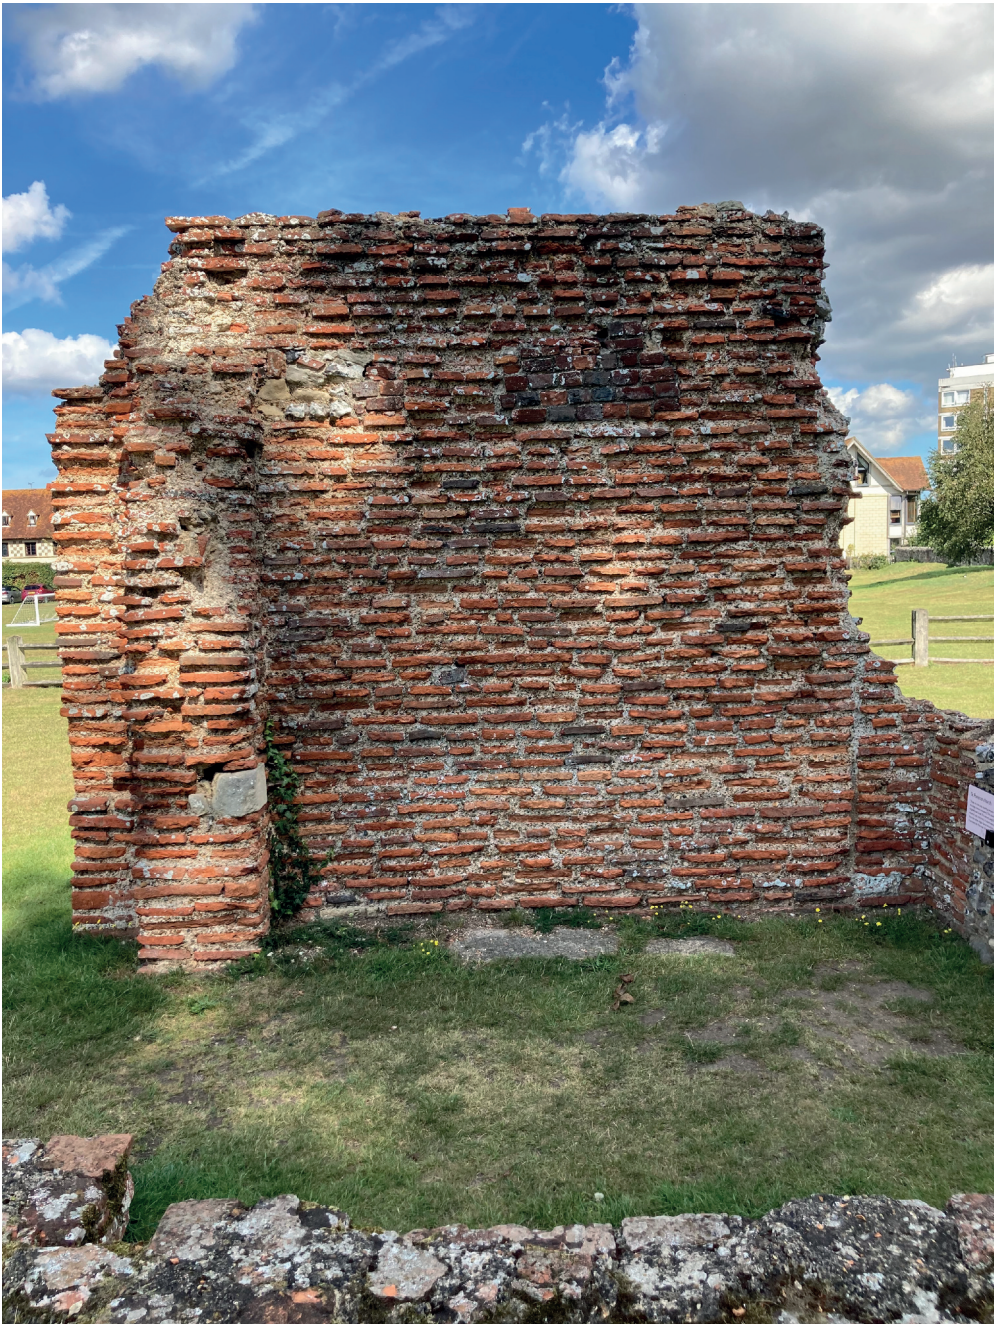
**Figure 23.** St Pancras, Canterbury. The south-facing elevation of the north wall of the west porch.
