Double jeopardy: the potential for problems when bats interact with breathable roofing membranes in the United Kingdom

Double Jeopardy: The Potential for Problems when Bats Interact with Breathable Roofing Membranes in the United Kingdom

S. D. Waring^{1,*}, E. A Essah², K. Gunnell³, R. H. C Bonser⁴

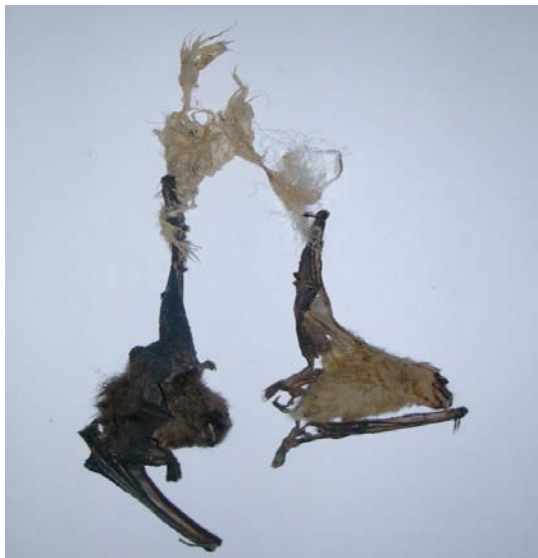
Fig.5. Two serotine bats found dead after becoming tangled in SBBP fibres pulled loose from a BRM (Photo Credit – Colin Morris, 2004, Dorset

UK)

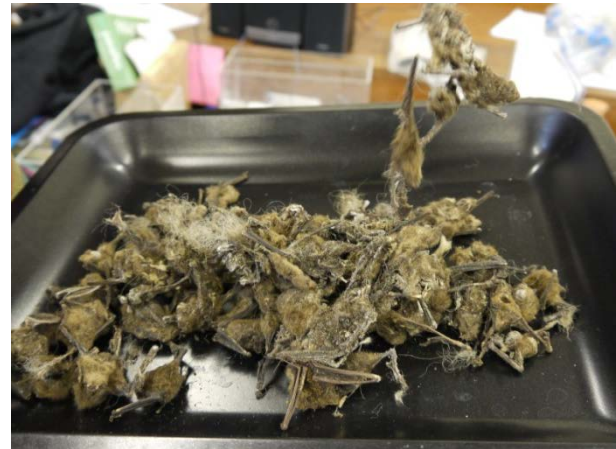
Fig.6. Large number of pipistrelle bats (104 were counted in total) found dead trapped in a BRM (Photo Credit –Stacey Waring, 2013, North Yorkshire UK)

In some species, the calls of distressed bats may attract other bats from within the roost to the area of danger, and with such behaviour recorded (Dietz *et al.*, 2009) this problem has the potential not to just affect individuals but larger numbers within the roost (Fig. 6).

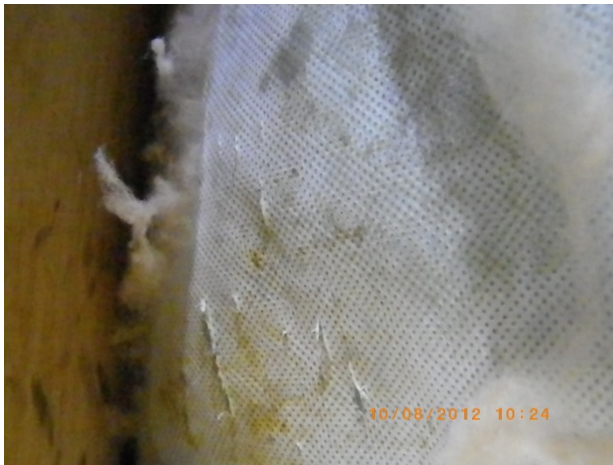
Fig.9. BRM showing damage to the functional layer six months after fitting in a bat roost (Photo Credit –John Martin, 2012, Cumbria UK)

A majority of BRMs (94%) inspected by the researcher following reports of problems, showed damage to the functional layer and in some cases the membrane had been worn away completely (Figures 9 and 10). In cases such as this, where the membrane has become damaged, this could allow any liquid water present under the tiles to enter the roof space, effectively reducing or removing the watertight properties of the membrane.

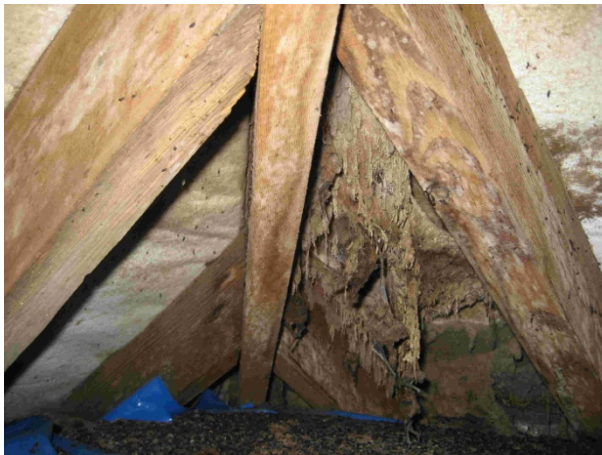
Fig.10. Damaged membrane in which 20 dead bats were found entangled (Photo Credit – Paul Scott, 2007, Dublin, Ireland)
