Double Jeopardy: The Potential for Problems when Bats Interact with Breathable Roofing Membranes in the United Kingdom

Abstract - In order to reduce environmental impacts and achieve sustainability, it is important to balance the interactions between the built and natural environment. The construction industry is becoming more aware of ecological concerns and the importance that biodiversity and maintenance ecosystem services has for sustainability. Bats constitute an important component of urban biodiversity and several species in the UK are highly dependent on buildings, making them particularly vulnerable to anthropogenic and environmental changes. Many buildings suitable for use as bat roosts often require re-roofing as they age and traditional bituminous roofing felts are frequently being replaced with breathable roofing membranes (BRMs). In the UK new building regulations and modern materials may substantially reduce the viability of existing roosts, yet at the same time building regulations require that materials be fit for purpose. Reports suggest that both bats and BRMs may experience problems when the two interact. Such information makes it important to understand how ho

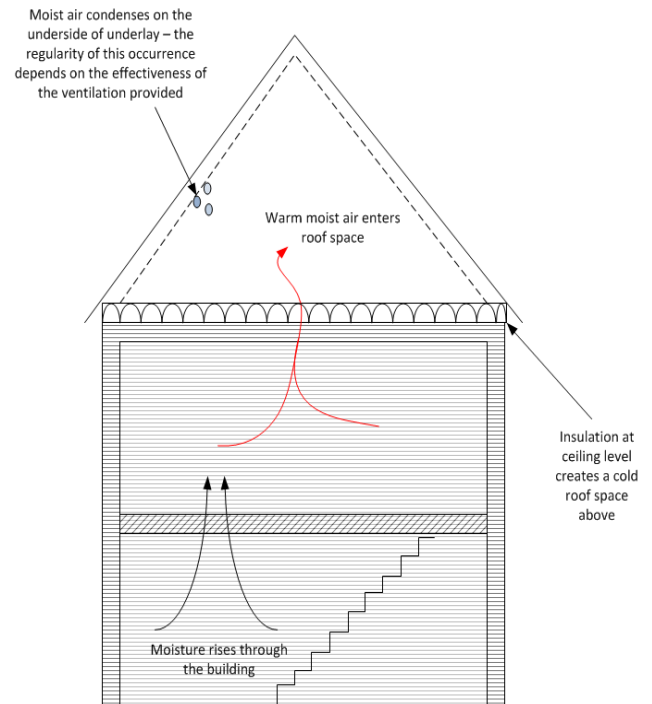
Fig.1. Formation of condensation in a pitched roof with insulation at ceiling level

the building (Chris Sanders, 2006). This can then lead to moisture moving through the buildings fabric via a combination of conduction, diffusion and convection (Sanders, 2006; Williams, 2008) (see Fig. 1).

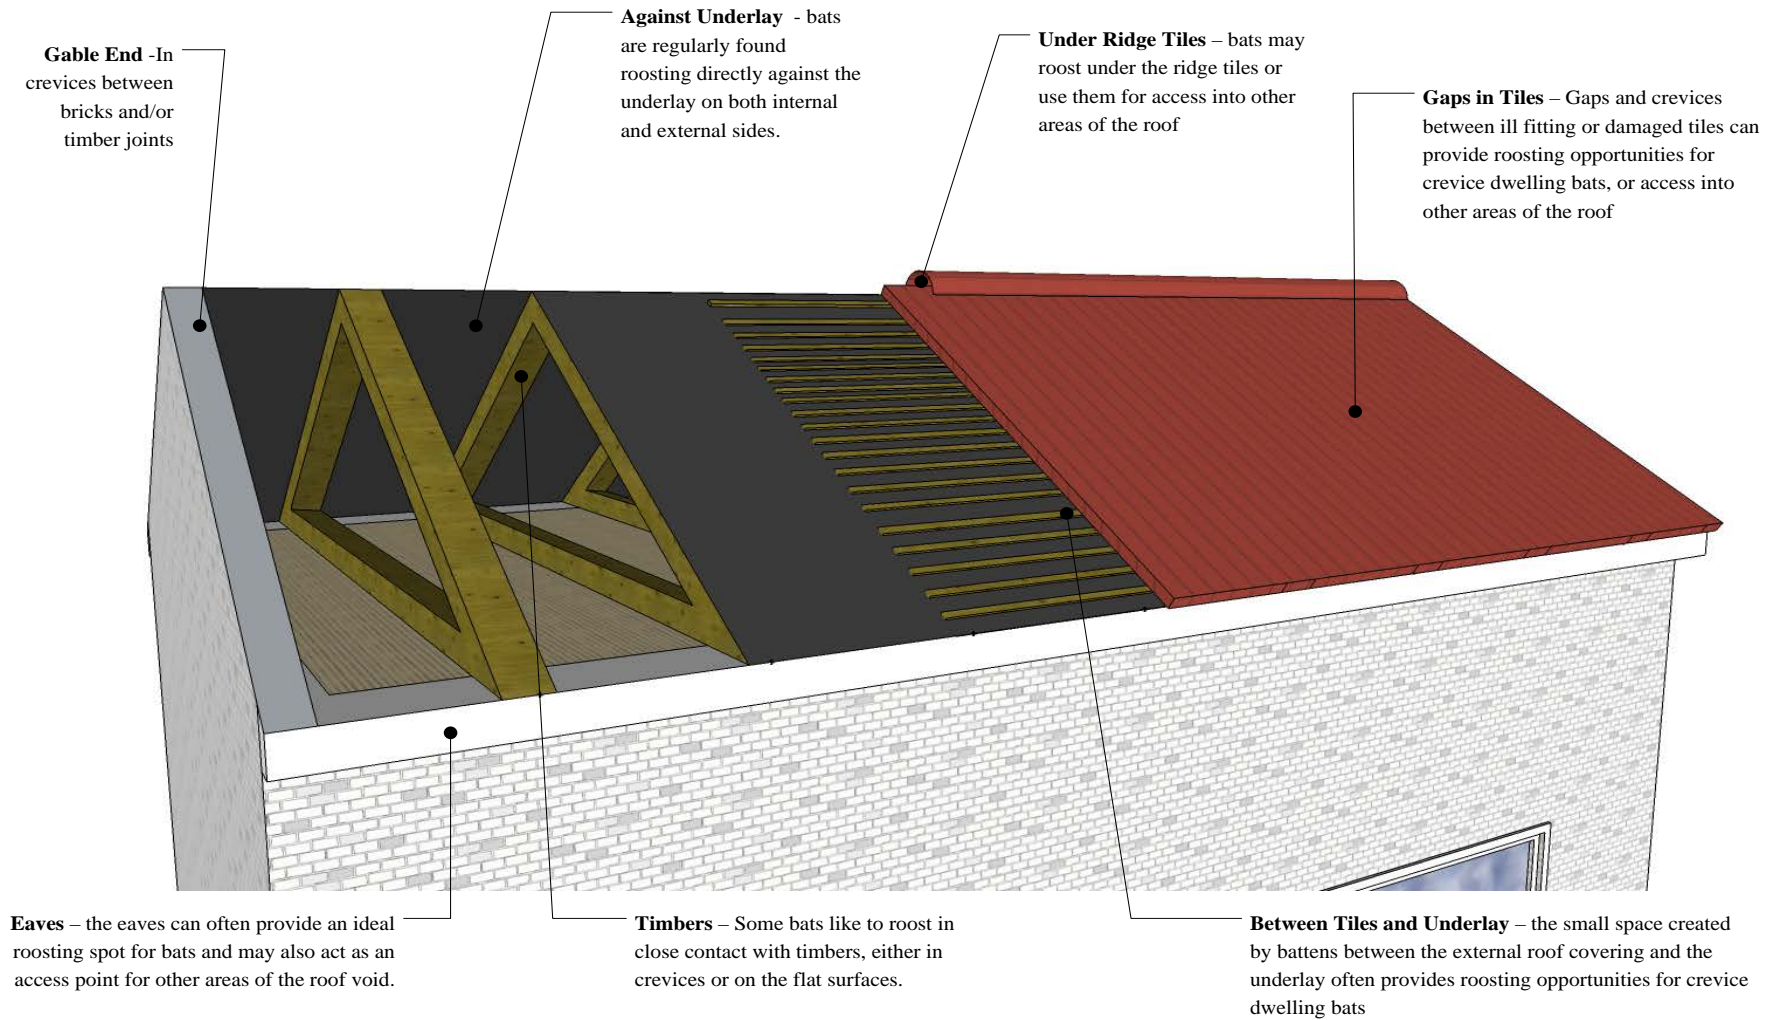
Fig.2. Areas where bats may be found roosting within a standard pitched roof in the UK

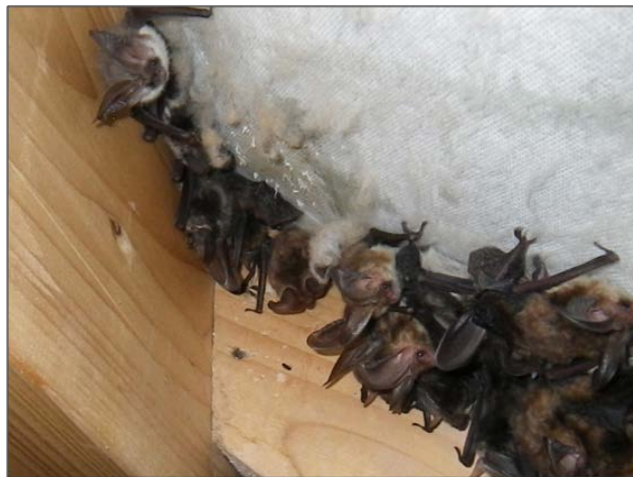
Fig.3. Picture of 'fluffing' on BRM six months after being fitted in a brown long-eared bat roost (Photo Credit - John Martin, 2012, Cumbria, UK)

Whilst industrial tests represent the stresses that BRMs may encounter within a normal roof space, they do not simulate the potential stresses the membrane may be exposed to in bat roosts. The problem with this is that neither test accounts for either the small scale of bats claws or the fact that they penetrate the SBPP fibres when gripping. This action may lead to bats grabbing the spun-bond fibres and teasing them apart. This then results in small clusters of fibres being pulled away from the main membrane which can be seen as a 'fluffing' on the surface of the BRM, which may pose an entanglement threat. Reports of bats found dead following entanglement are becoming increasingly common, as roosts where BRMs have been fitted are being re-visited. In some cases BRMs are showing signs of entanglement potential within months of the bats returning, after the BRM had been fitted. Figures 3 and 4 show 'fluffing' of two different membranes, both of which had been fitted in brown long-eared bat roosts only 6 months prior to the visits. In other scenarios BRMs are being removed from projects that were re-roofed up to 15 years ago and large numbers (between 12 and 104) of dead bats are being found tangled in filaments that have been pulled loose.

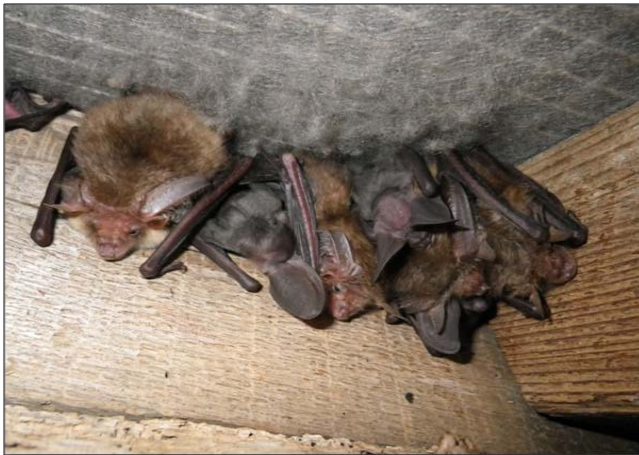
Fig.4. Picture of 'fluffing' on BRM six months after being fitted in a brown long-eared bat roost (Photo Credit - John Martin, 2012, Cumbria UK)

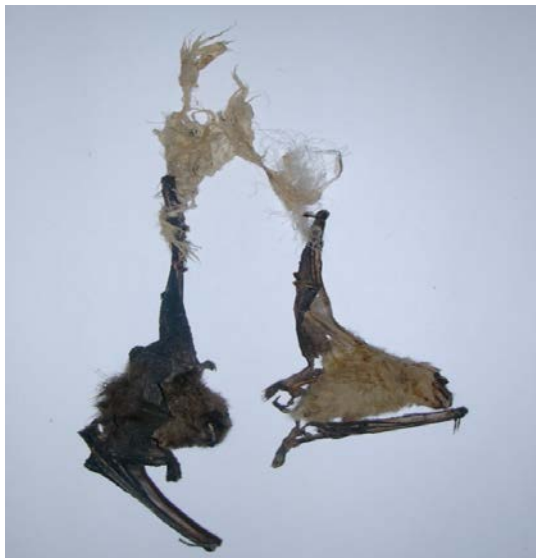
Fig.5. Two serotine bats found dead after becoming tangled in SBBP fibres pulled loose from a BRM (Photo Credit – Colin Morris, 2004, Dorset

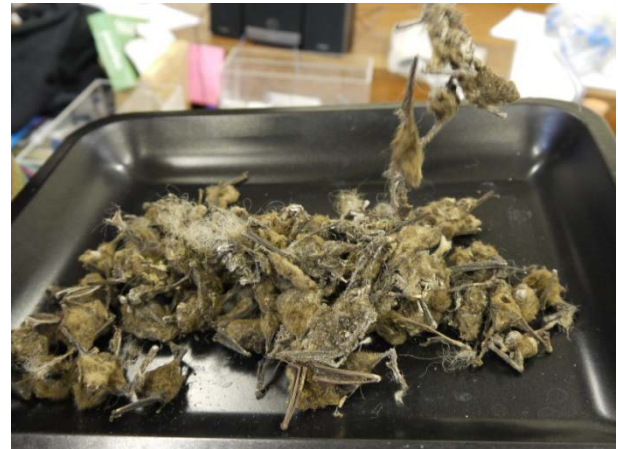
Fig.6. Large number of pipistrelle bats (104 were counted in total) found dead trapped in a BRM (Photo Credit –Stacey Waring, 2013, North Yorkshire UK)

In some species, the calls of distressed bats may attract other bats from within the roost to the area of danger, and with such behaviour recorded (Dietz *et al.*, 2009) this problem has the potential not to just affect individuals but larger numbers within the roost (Fig. 6).

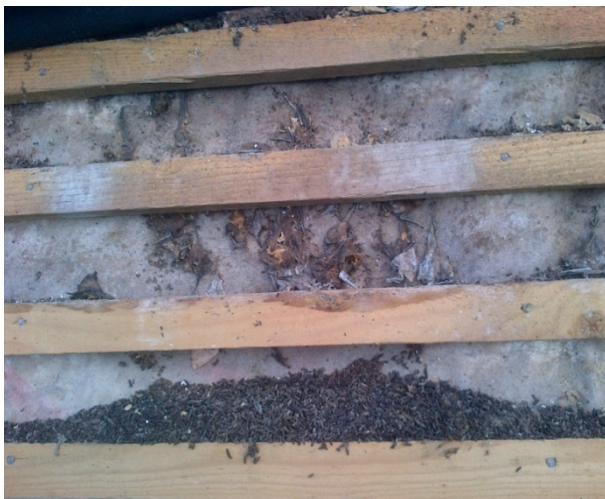
Fig.7. Faeces build-up between BRM and the roof tiles. Thirty bats were also found dead following entanglement in loose filaments (Photo Credit - Rob Gray, 2012, Oxfordshire UK)

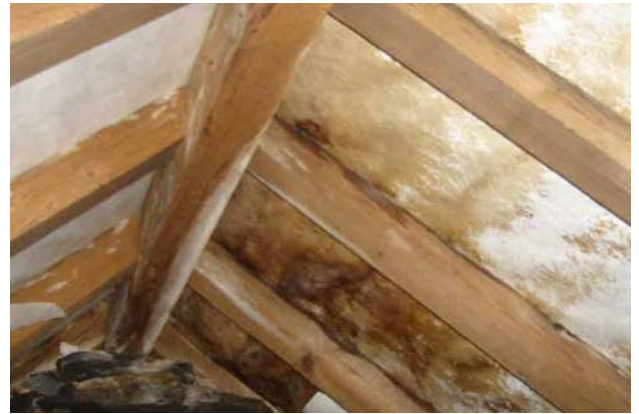
Fig.8. Staining of a BRM through absorption of excrement (Photo Credit - Shirley Martin, 2010, Cumbria UK)

Due to an insectivorous diet bat faeces easily crumble into a fine powder and so can be distributed across the membrane surface. Furthermore, urine is also easily absorbed into BRMs and can be seen as staining in roof spaces where bats are roosting against BRMs (Fig. 8).

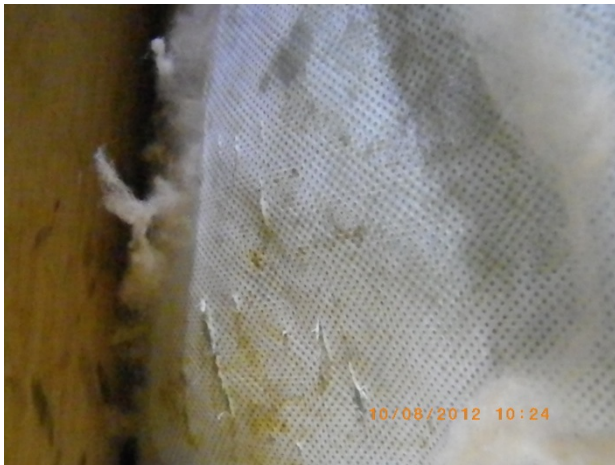
Fig.9. BRM showing damage to the functional layer six months after fitting in a bat roost (Photo Credit –John Martin, 2012, Cumbria UK)

A majority of BRMs (94%) inspected by the researcher following reports of problems, showed damage to the functional layer and in some cases the membrane had been worn away completely (Figures 9 and 10). In cases such as this, where the membrane has become damaged, this could allow any liquid water present under the tiles to enter the roof space, effectively reducing or removing the watertight properties of the membrane.

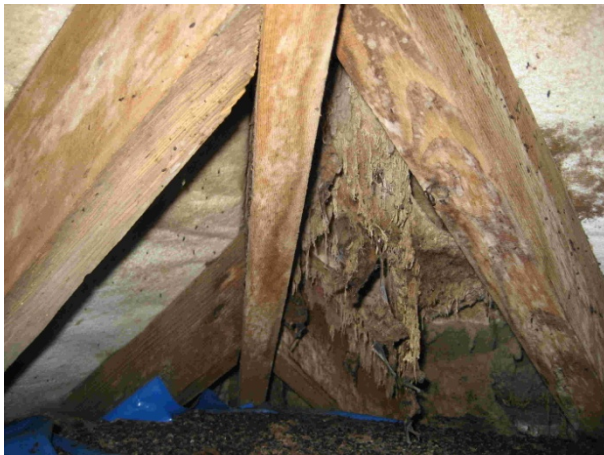
Fig.10. Damaged membrane in which 20 dead bats were found entangled (Photo Credit – Paul Scott, 2007, Dublin, Ireland)
