# Retrofit Planning for the Performance Gap: Results of a Workshop on Addressing Energy, Health and Comfort Needs in a Protected Building

**Abstract:** Research on the performance gap suggests that the actual energy consumption in buildings can be twice as much as expected from modelled estimates. Energy models rely on predictive indicators and assumptions that are usually done at the design stage, without acknowledging behavioral patterns of actual users, amongst other uncertain elements. Moreover, in the context of the performance gap, it is evident that energy efficiency is overemphasized while other key issues such as health and comfort of occupants associated with indoor air quality, noise levels etc., have been less stressed and discussed. This paper discusses physical measurements of indoor temperature in a case study building at the University of Cambridge and reports findings of a workshop with researchers, building professionals and graduate students working on environmental performance in the built environment. The workshop addressed research issues related to energy, comfort and health (couched in terms of thermal performance), used as a means to understand the complex

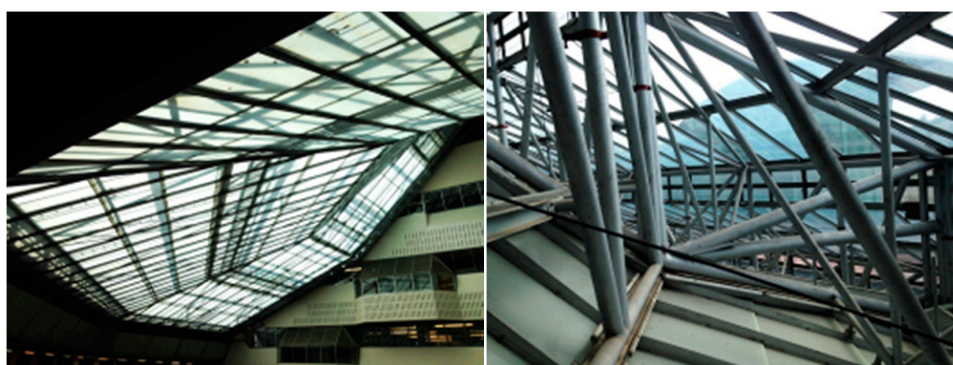
**Figure 2.** Glazed, double-skin roof of the library from inside the library (left) and inside the cavity (right).

The main reason for the poor thermal comfort and high energy use is that 75% of the envelope above the plinth is standard industrial glazing, along with the giant stepped-pyramid skylight of the

library (Figure 2). The glazed, double-skin roof in the library was meant to act as a light diffusing layer where the inner layer was obscured to prevent glare and to give shadowless light in the reading area. This was also designed to insulate the cavity between the two skins so that all the louvres in the vertical steps would be closed in winter and opened in the summer to enable ventilation through the stack effect. Artificial light sources in the cavity and the roof provide an ‘overhead spectacle’; however, the library space and office spaces are prone to overheating in summer (and to draught in winter). The noisy extraction fans in the library were never used and small air-conditioning units have been placed in the administrative corridors. Offices have draughty glass louvres for ventilation, along with secondary glazing and venetian blinds that have been installed during later renovations. It was predicted (somewhat dismissively) as early as 1968 that “controls will be fouled up through mismanagement by the humanities-oriented occupants who are below the average in mechanical literacy and competence, while the occupants will take verbal revenge on the architects—whereas revenge should be on UGC and their budgets that are too ‘skimp’ to permit decent environmental installations or idiot-proof control systems” [18].
