Dempsey, K. (2018) Lea Castle: looking outwards. Château Gaillard, 28. pp. 113-119. ISSN 2491-844x (Études de castellologie médiévale, n° 28 : L'environnement du château) Available at https://centaur.reading.ac.uk/78922/

Lea Castle: Looking Outwards

Karen Dempsey

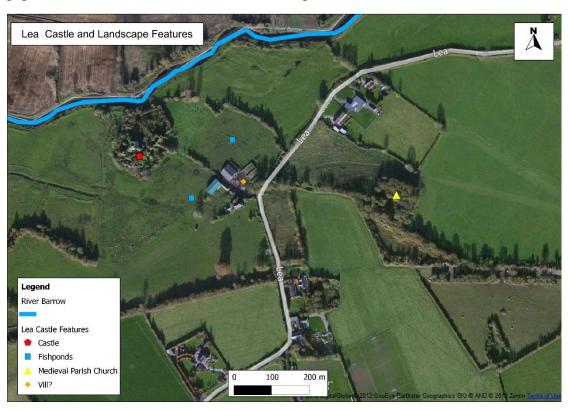
Fig. 1 - Lea Castle, Co. Laois: interpretative aerial image indicating the landscape arrangement and potential features. Photograph Karen Dempsey. Bing Images

The first completed in 2015, concentrated on the areas west, south and south-east of the castle, including the areas adjacent to the modern farmyard (fig 1). This revealed the return of the moat, over four depressions, both linear and sub-circular in shape that may be a series of interlinking fish-ponds and rectangular features which are interpreted here as possible house plots. However, all of these potential archaeological features are as yet unconfirmed. In 2016, the survey area was expanded to include a large field east and north east of the castle, which had some

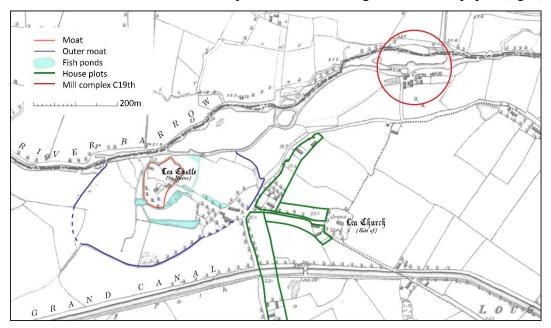
Fig. 2. Lea Castle, Co. Laois: interpretative image based on historic mapping exploring the potential medieval landscape. Source: First Edition Ordnance Survey mapping (1841). After Myles 2015; drawing K. Dempsey and C. McDermott.

Today, the landscape of Lea Castle is criss-crossed with modern drainage ditches; however, initial observations of the archaeological remains and study of the cartographic evidence, including an antiquarian plan from the 18th century, indicate evidence for an intricate waterscape which is re-imagined for this paper (fig 2).

Centrally placed within this landscape, traversing the putative moats and possible fish-ponds, a potential raised route-way may once have given access to and from the castle. Parallel field boundaries, only partially extant today but visible in historic mapping and noted on an antiquarian drawing represent this. Interestingly, it leads east-southeast towards the medieval church. It seems to create a physical link between the church and castle. Indeed, this could be read as a material statement of the ongoing, inseparable dialogue between the sacred and profane in the medieval world. The raised route-way terminates at the putative medieval *vill* beyond which further east is access to the church lane and medieval church (fig. 2).

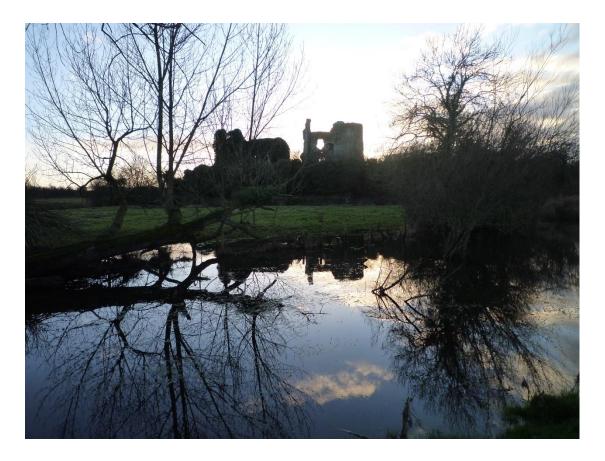
Fig. 3 - Lea Castle, Co. Laois: view across watery landscape facing west-northwest. Photograph Karen Dempsey.
