# *Fat, oil and grease reduction in commercial kitchen ductwork: a novel biological approach*

Article

# **Fat, Oil and Grease Reduction in Commercial Kitchen Ductwork: a Novel Biological Approach**

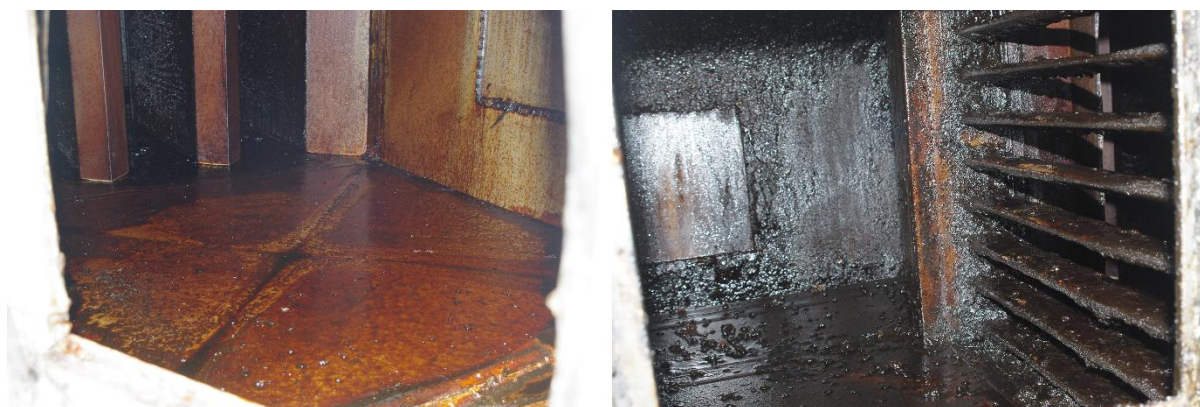
**Figure 3: Trial site ventilation duct interior 3 weeks post manual duct clean**

The novel system was trialled at a live working restaurant in Hampshire, South East England. The site was selected due to its known frequent requirement for manual duct cleaning. The FOG reduction strategy previously employed by the site was five in-hood single-stage, baffle-type lamb's wool filters. Despite these filters, the site employed 4-6 manual cleans per year (Figure 3).

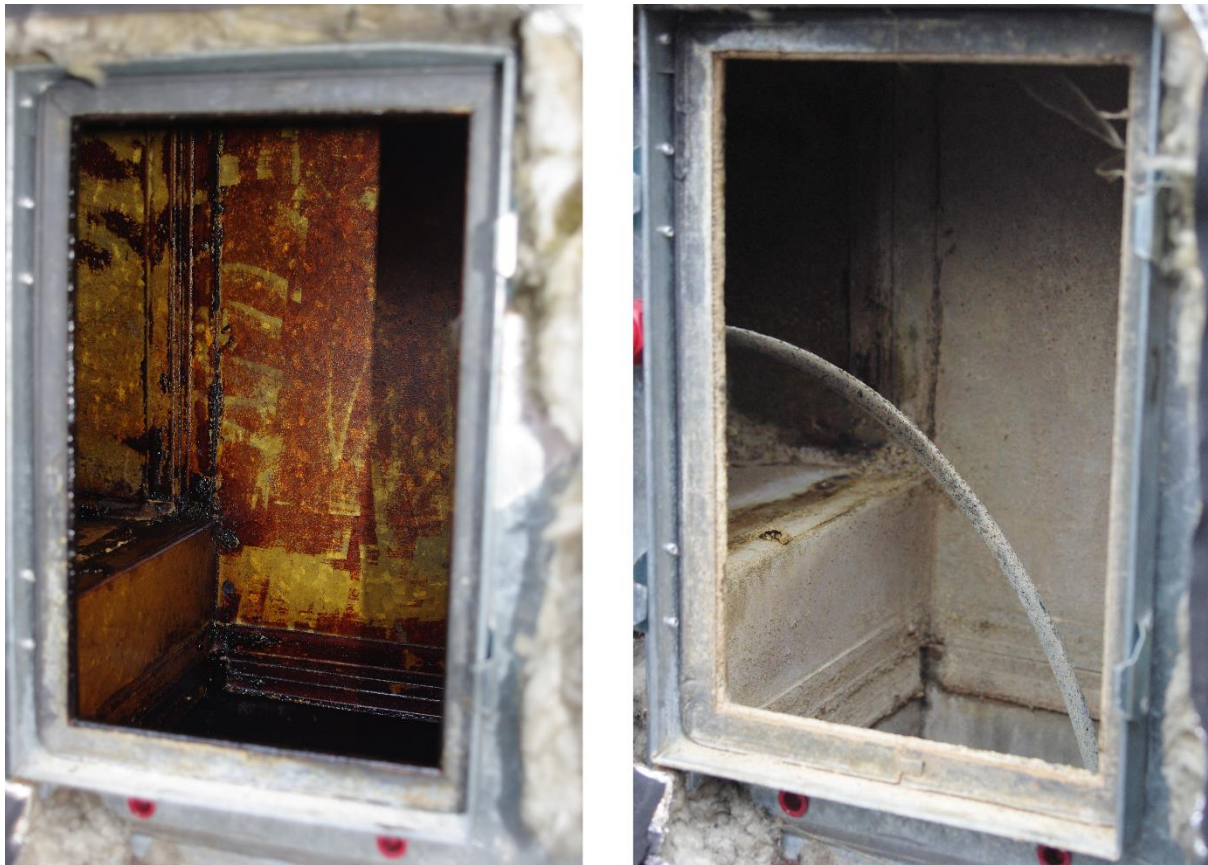
The most striking results were found in Hatch 1 which saw reductions of 887 $\mu\text{m}$  (72%) from 1239 $\mu\text{m}$  to 352 $\mu\text{m}$  (Figure 7). More marked reduction in this location is due to the fact that this end of the duct is situated above a microwave combi oven which emits less particulates than the gas fired chargrill, which was situated under Hatch 8 (the least affected hatch location).

**Figure 7: Hatch 1 pre-installation (left) and 2 months post-installation (right)**
