# *Comparative study of the road roughness measurement of Roadlab Pro and Roadroid applications for IRI data collection in Nigeria*

## Comparative Study of the Road Roughness Measurement of Roadlab Pro and Roadroid Applications for IRI Data Collection in Nigeria

<sup>1</sup> Nigerian Building and Road Research Institute, Abuja Nigeria

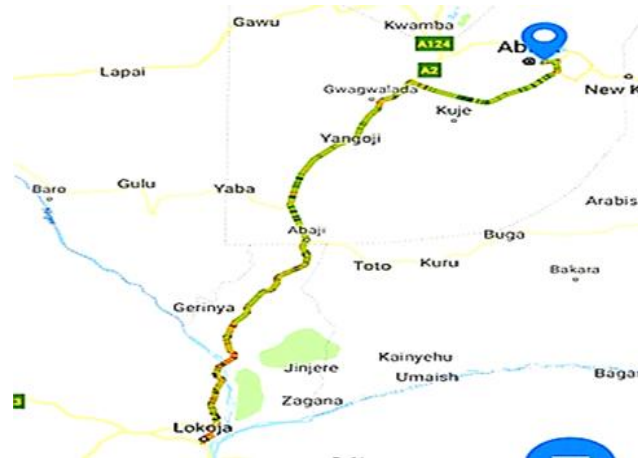
Figure 2: Screenshot of IRI measurement for road link (RoadLab Pro)

From data collected by RoadLab Pro, total surveyed length is 392.25km with average speed of 87.91km/h. 99.74% of the total survey length recorded an average IRI of 3.13; classified as good. Most section of the road link recorded IRI values classified as good as seen in Figure 2 where significant section of the route link is within the green colour range.

From both data collected, there is a 0.008% and 0.58% error margin of the total surveyed length and average speed of road link in clockwise and counter clockwise direction. From visual observation, this route has the longest road link with severe rutting with total surveyed length of about 0.03km. This may mean that the sensors can detect roughness on pavement surface with rut. Also, IRI values for both applications are captured within similar condition category as seen in Table 1 and Table 2.

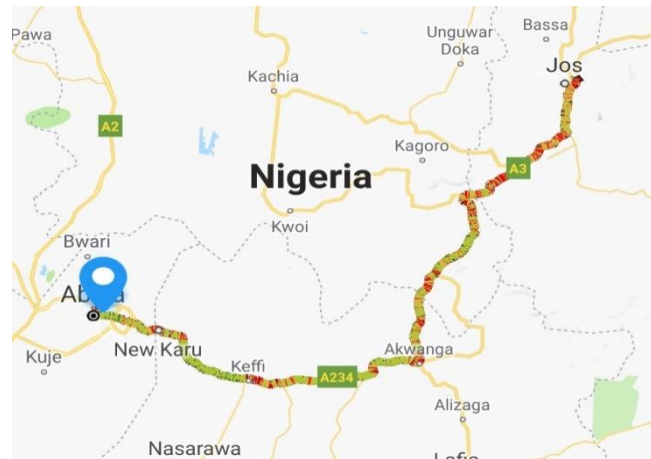
Figure 4: Screenshot of IRI measurement for road link (RoadLab Pro)

From data collected by RoadLab Pro, total surveyed length is 556.86km with an average speed of 75.98km/h. Roughness measurement from the application showed that 98.67% of the total surveyed length was measured with an average IRI of 5.00, classified as fair. Predominantly, the road section recorded IRI values that are categorized as fair with the remaining section, partly good and poor. The visualization of the IRI data retrieved from RoadLab Pro shows that significant part of the road link from Akwanga to Jos as seen in Figure 4 have IRI greater than 6; implying poor condition level.

Result also shows a 0.34% and 3.33% error margin of total surveyed length and average speed between applications. Also, the IRI values are classified in different IRI condition category.
