# *Assessment of overheating risk in gynaecology scanning rooms during near-heatwave conditions: a case study of the Royal Berkshire Hospital in the UK*

# Assessment of Overheating Risk in Gynaecology Scanning Rooms during Near-Heatwave Conditions: A Case Study of the Royal Berkshire Hospital in the UK

**Abstract:** Hospital buildings in the UK are at particular risk to rising summer temperatures associated with climate change. Balancing the thermal needs of patients, staff, and visitors is a challenging, complex endeavour. A case study of the ultrasound area of the Royal Berkshire Hospital's Maternity and Gynaecology building is presented, where temperatures were measured for 35 days in waiting areas, staff offices, and ultrasound scanning rooms, aiming to assess the overheating risk posed to occupants. Local external temperature measurements were used for comparison whereby determining the indoor-outdoor environmental connection. Results show that most rooms had already breached standard overheating thresholds within the study period. Anthropogenic and waste heat from equipment has a noticeable effect on indoor temperatures. Local air-conditioning helped reduce the peaks in tem

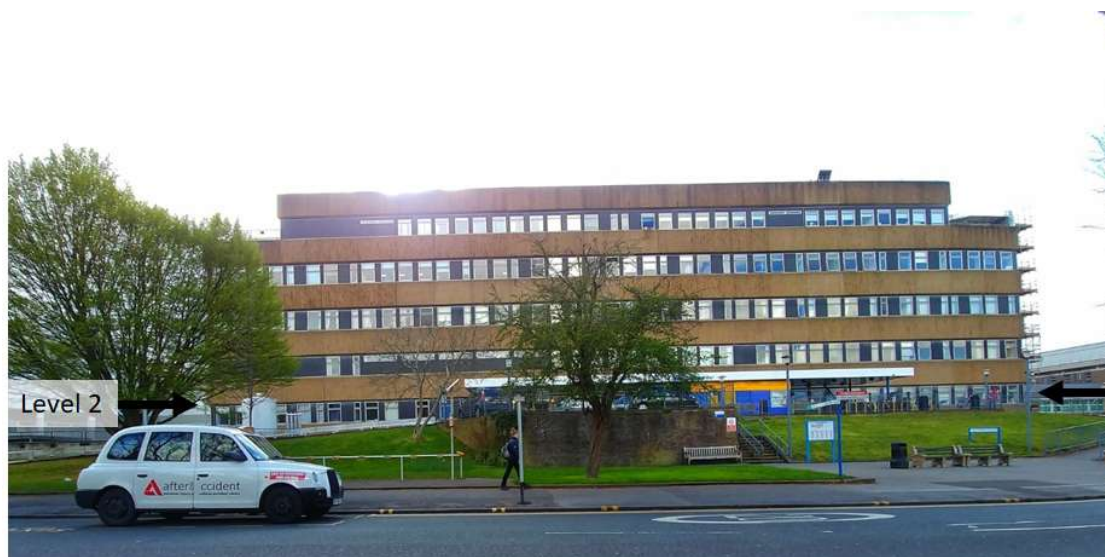
**Figure 1.** Photo of the Maternity and Gynaecology building taken from across the road. The black panels seen around the windows are asbestos. Level two is the ground floor of the building, highlighted by the black arrows, with the two entrances (Figure 2) located under the white awning.

This building was built in the 1960s and constructed of mostly concrete and asbestos with no façade shading. Windows are single-glazed with ill-fitting frames. The building was not designed to facilitate the anthropogenic, IT, and electronic heat loads seen in a modern M and G department. There is a mechanical ventilation system mainly used for heating, but it is turned off in the Summer

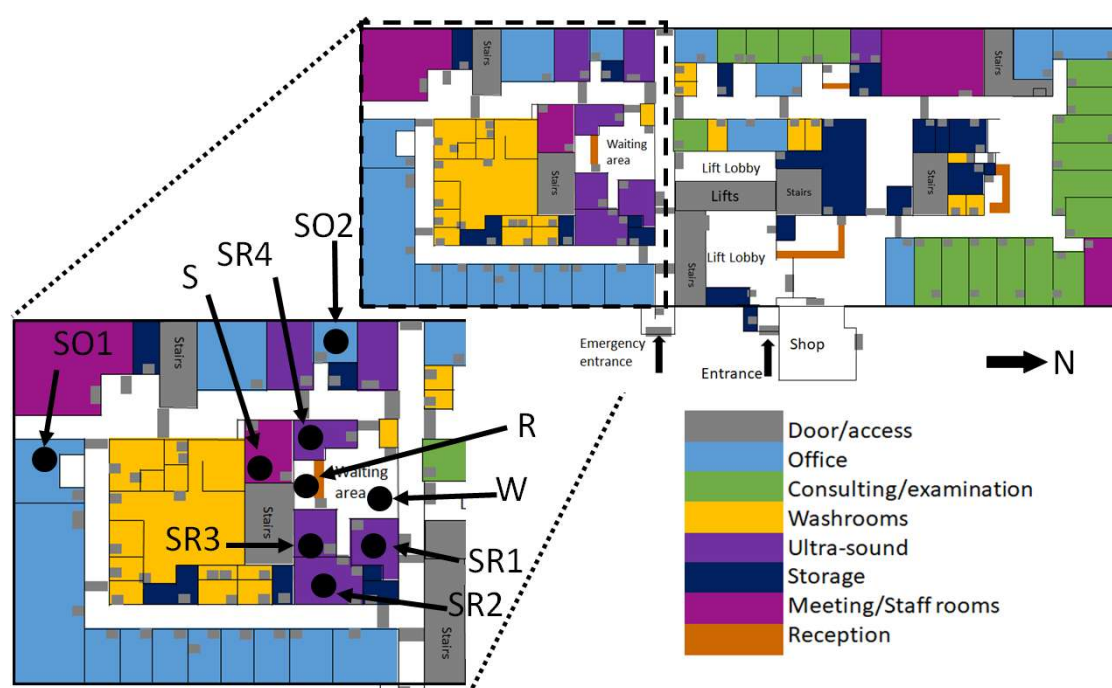
**Figure 2.** Floor plan of level 2 of the Maternity and Gynaecology building, colour coded by room use. Total area: 2162.52 m<sup>2</sup>. Cutaway shows the focus area of the study and the symbols for sensors and locations are described in Table 1. The map is based on building plans provided by RBH.

The focus area of the study was the waiting/reception area (capacity: 20–30 people) and staff break room (capacity: 10 people) associated with the ultrasound scanning rooms (6 rooms, 4 sealed, 2 naturally ventilated) on Level 2, the ground floor (Figures 1 and 2). The only rooms with windows are the ones directly connected to the building façade, in this case, the two staff offices (Figure 2, marked as SO1, SO2 respectively). Only the scanning rooms without direct natural ventilation (four) are monitored. These are positioned within the centre of the building (Figure 2). Room 3 (Marked as Sensor SR3) has air-conditioning available to use, with a portable air-conditioning unit also being deployed (unknown date of deployment and operation times) in the waiting room in front of the reception desk (Figure 2). Sensor naming convention is shown in Figure 2. Occupants of these areas include admin, cleaning, and clinical staff (all day), patients and pregnant patients (<5 h stay), all of whom will be negatively affected by high indoor temperatures [40]. Varying environmental conditions have also been reported across the entire floor and building (Figure 2).

**Table 1.** Symbols used for sensors, room size and location within the test area. Locations are shown in Figure 2.

Natural ventilation is not a viable solution in this area of the RBH, due to the central position of the at-risk scanning rooms within the building (Figure 2). Also, within heatwave conditions, it is expected that air-pollution also increases, adversely affecting those with respiratory conditions [18]. Refs. [24,45,46] highlight that there are few examples of innovative natural ventilation/passive cooling strategies being used in hospital buildings, due to risk-adverse procurement and tight budget constraints. Noise may also prevent windows and doors from being opened. Whilst this study has focused on temperature, other factors, such as airflow, moisture, and odour also influence thermal comfort and may also need to be considered for specific patient groups. Other more complex ventilation solutions are described in [45].

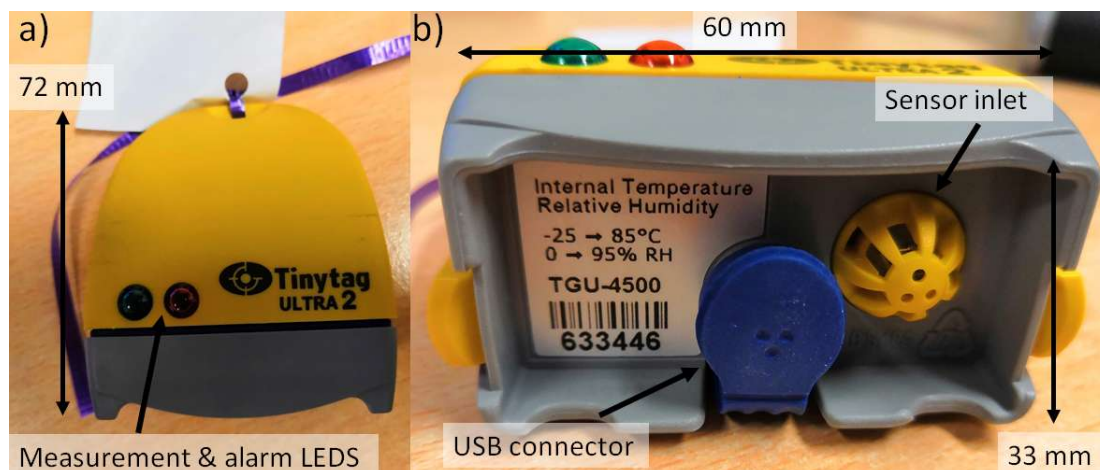
**Figure 3.** Images of the Tinytag sensors deployed (a) plan view and (b) closeup of the sensor base where the inlet is visible. All sensors had a piece of paper attached describing what they were measuring and who to contact if issues arose.

Temperature and humidity within the internal environment were measured using nine Gemini Tinytag Ultra 2 TGU-4017 temperature loggers (temperature range −40 to 85 °C) chosen for their

splash-proof case, self-contained design and USB (Universal Serial Bus) connection (Figure 3). Where possible sensors were positioned out of direct sunlight (only a problem for the Staff Offices, see Figure 2) and away from windows or any office equipment which may generate waste heat. Within the waiting room, the sensor was placed in the corner of the room, out of sight, but within the area where patients sit and wait.

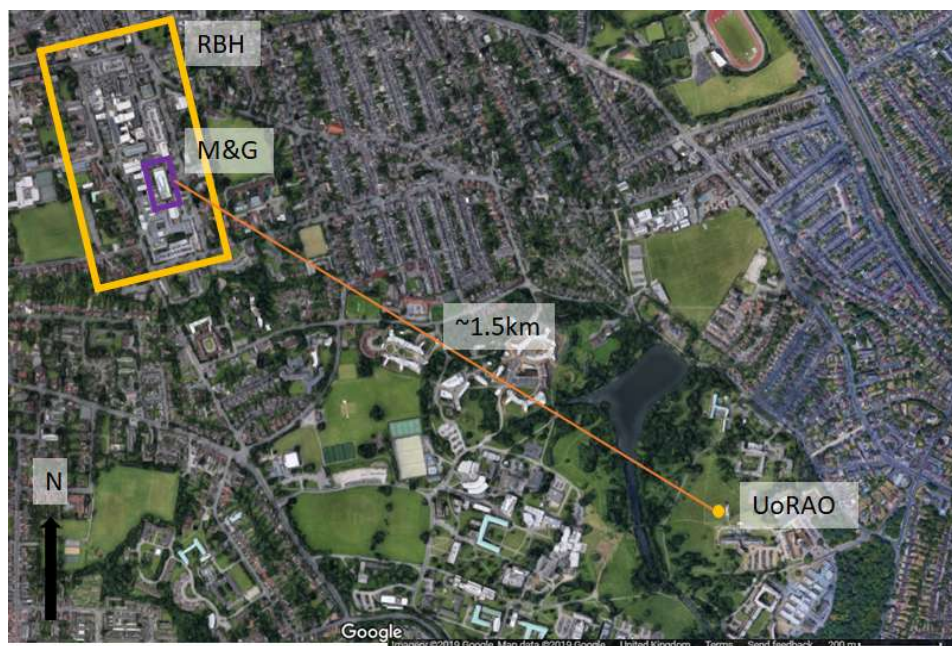
**Figure 4.** Location of the University of Reading Atmospheric Observatory (UoRAO, dot) in comparison to the Royal Berkshire Hospital site (RBH, box). The Maternity and Gynaecology (M and G) building (Figure 1) is highlighted within the RBH site.

Reference external temperatures were measured at the University of Reading's Atmospheric Observatory (UoRAO), also at five-minute intervals as part of the automated system (accuracy: 0.1 °C). The temperature of concrete was also logged. The climate conditions of Reading can be classed as temperate. UoRAO is approximately 1.5 km as the crow flies from the Maternity and Gynaecology building (Figure 4). For details on the experimental set up of the UoRAO and measurements available see [41]. Whilst this distance is small, the external temperatures around the hospital site may be slightly warmer due to the urban heat island effect. Figure 5 details the background weather conditions throughout the campaign, with little rain being recorded (Figure 5a). Low wind speeds (95 % were  $<6 \text{ m s}^{-1}$ ) were recorded throughout the study period and for most of the study period, the wind direction remained within the prevailing sector for the area (Figure 5c).

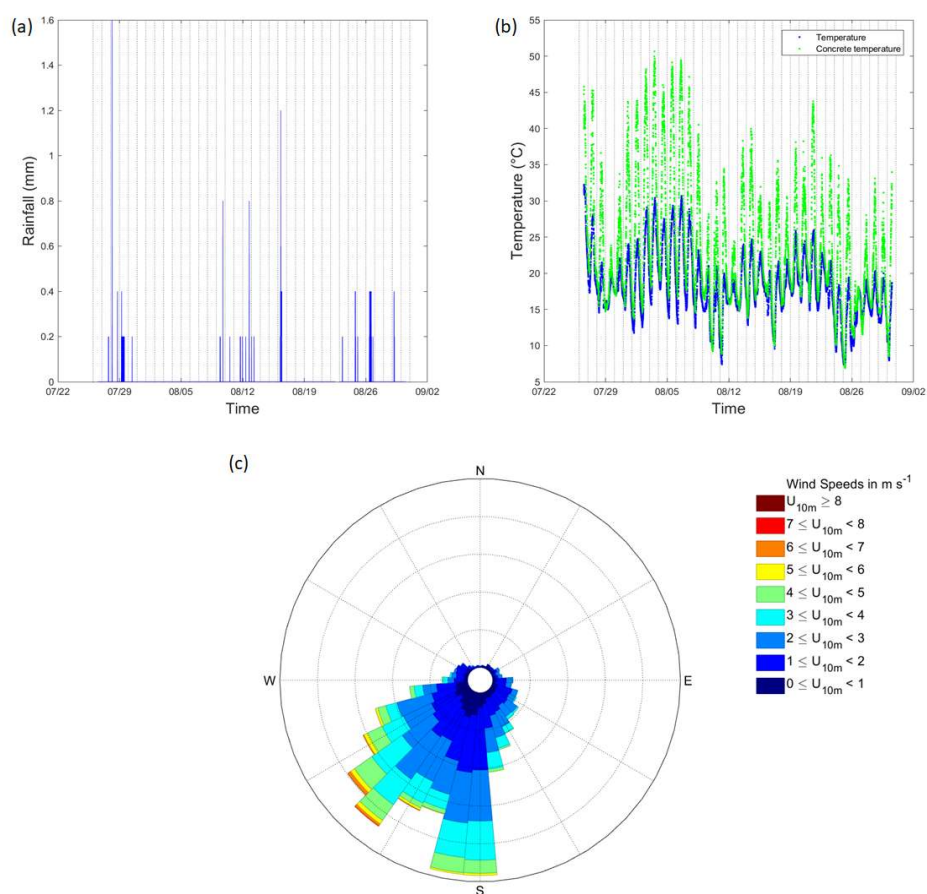
**Figure 5.** Observations from UoRAO for the study period. (a) rainfall, (b) temperature and concrete temperature, and (c) wind direction and 5-min wind speed at 10 m (meteorological standard). Vertical grey lines denote midnight of each day.

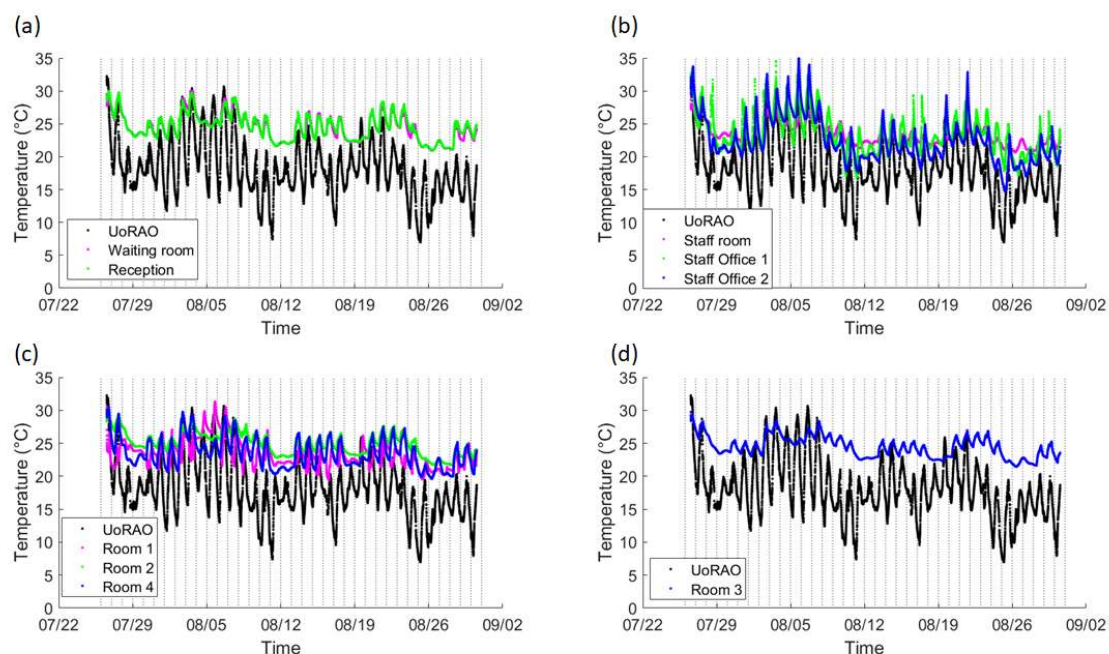
**Figure 6.** Overview of the temperatures recorded for the entire study period. Vertical lines denote midnight of each day. For clarity, similar rooms are plotted on one subplot, (a) Observatory (UoRAO), waiting room and reception, (b) UoRAO and Staff room and offices, (c) UoRAO and the naturally ventilated scanning rooms (Room 1,2,4) and (d) UoRAO and room 3, the air-conditioned room. All plots have the same axis.

A diurnal cycle is present for all rooms, with more extreme temperatures being seen in the Staff offices, due to them being located on the building's exterior (Figure 2, Figure 6b). The staff offices are also where the lowest indoor temperatures are recorded during the evenings, due to the rapid release of heat from the building's surface and potential ventilation. The waiting room and reception area (Figure 6a) both record similar conditions due to them being linked, with the waiting room having lower minimum temperatures due to it being closer to the main entrance (automated sliding double doors ~1.5 m across) and the effect of the temporary air-conditioning unit (Figure 2). The staff room also displays a similar trend, though with larger daytime spikes due to the lack of ventilation because of closed doors for privacy and security reasons (Figure 7b). The ultrasound scanning rooms all show slightly different behaviours, with room three displaying lesser peaks due to the use of air-conditioning, but even with air-conditioning, there is still a notable peak throughout the day, suggesting the current unit is struggling to maintain temperatures, even in the smallest scanning room (Figure 6c,d and Table 1).

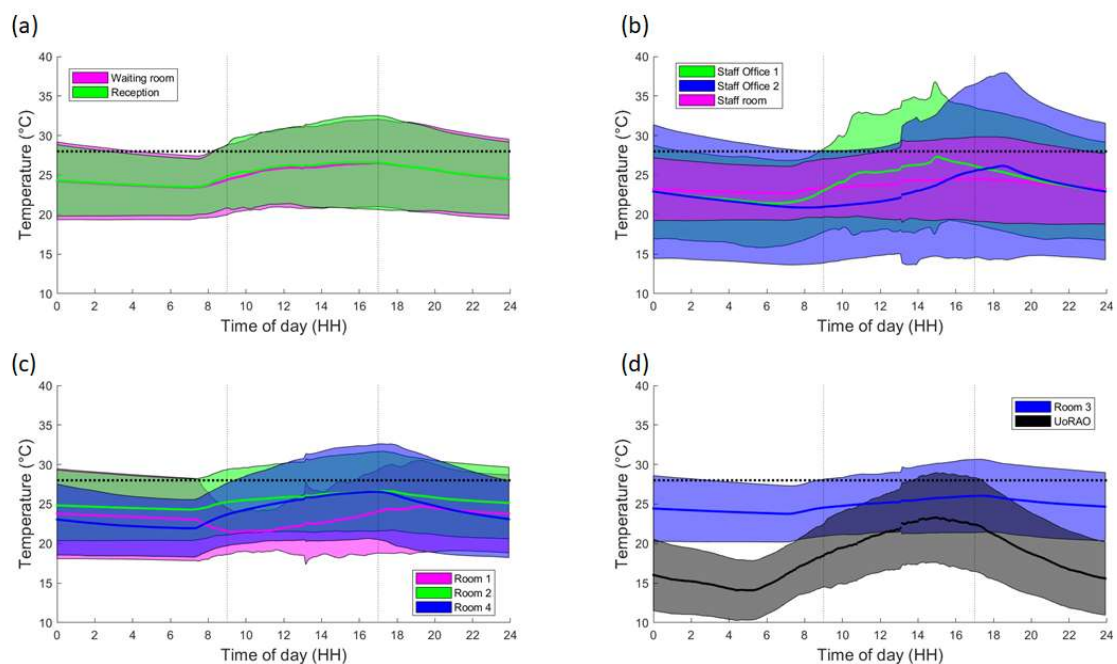
**Figure 7.** Time-averaged trend of weekday temperatures within the rooms. Line denotes the mean temperature per five minutes, with the shading denoting three standard deviations. (a) Waiting room and Reception, (b) Staff offices and the Staff room, (c) Rooms 1, 2 and 4 and (d) Room 3. Note that for clarity the UoRAO data is on plot d). Clinic hours are highlighted by the dashed vertical lines. The CIBSE threshold of 28 °C is shown in the thick horizontal dashed line.

Removing the weekend data and averaging over all weekday data further highlights the differing behaviour of the scanning rooms throughout clinic times (Figure 7c,d). On average staff office 1 experiences a peak in mean temperatures at around 15:00, whereas Staff office 2 peaks between 18:00 and 19:00 (Figure 7b, Figure 8b), with some of the highest maximum temperatures (30–35 °C) being recorded here (Figure 9b). This is most likely due to the solar gain of those offices. Based on room positioning time of year, Staff office 1 would have maximum solar gain between 11:00–14:00 (south-facing) and Staff office 2 (west-facing) 16:00–19:00. Staff office 2 also experiences the lowest temperatures, which is a concern for the winter months, as, despite windows being closed, it is a similar temperature to UoRAO temperatures during the evening (Figure 7b). More research into occupant adaptation and behaviour is required.

The staff room has a peak in temperature at around 14:00, linked to anthropogenically created heat from lunch breaks between 12:00 and 14:00 (Figure 7b, Figure 8b). The waiting room and reception areas experience a slow rise in temperature throughout clinic times (Figure 7a), with maximum temperatures occurring most frequently between 12:00 and 17:00, in part due to the presence of people (Figure 8a). This rise in temperature is less steep than the scan rooms (Figure 7c) due to the proximity to the entrance doors, less equipment, and the influence of the portable air-conditioning unit installed within the waiting area.

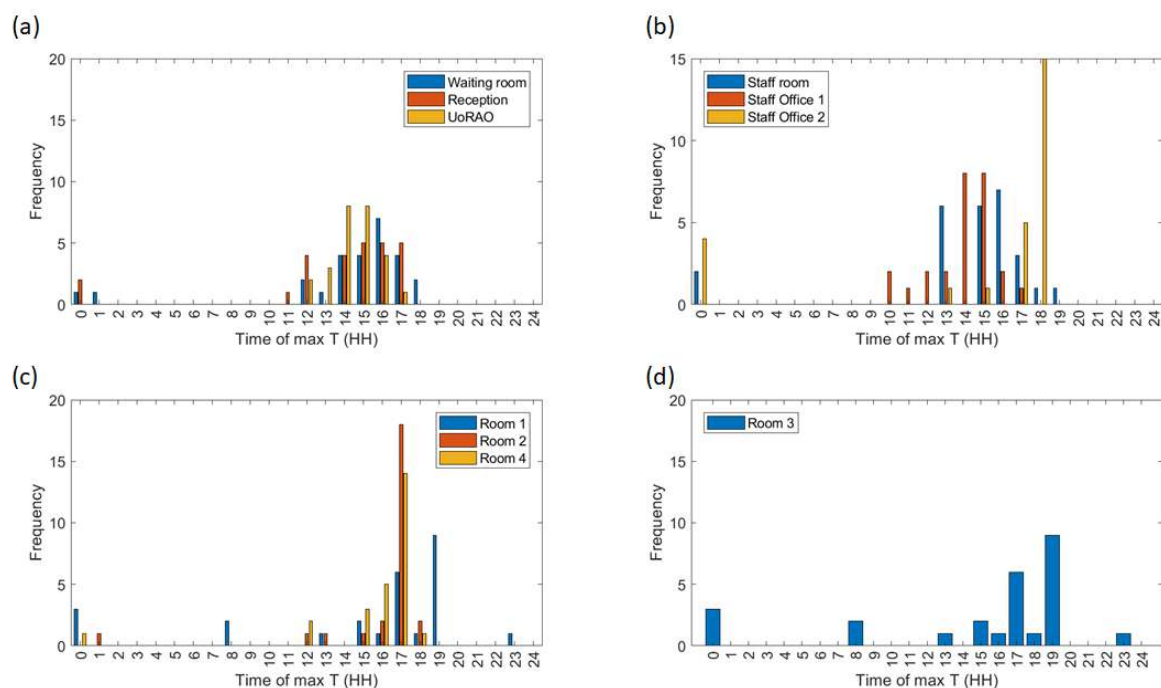
**Figure 8.** Hours in which the maximum daily temperatures recorded on the weekdays occur (Figure 9). For clarity, similar rooms are plotted on one subplot, (a) Waiting room, Reception and the observatory (UoRAO), (b) Staff room and Staff offices, (c) Room 1, 2, 4 and (d) Room 3. All plots have the same axis.

A large variation is seen in the daily average temperatures for scanning rooms 1, 2, and 4, with all tending towards a peak in mean temperatures at 17:00 (Figure 8c), an accumulation of high external temperatures, waste heat from equipment and anthropogenic heat (Figure 7c). Scan room 3's mean temperature is kept fairly constant due to the air-conditioning unit (operated by staff, with heat extracted to the roof) with its most frequent daily maximum temperatures being 1–2 °C lower than the other rooms (Figure 9c,d). Differences between rooms 1, 2, and 4 are likely due to differing usage patterns, size, staff preference, location of different equipment, and differing structure (Figure 2). The time of the daily maximum temperatures of Scan room 3 is slightly later than the other rooms, due to the air-conditioning unit being turned off after clinic hours and the room returning to equilibrium (Figure 8d).

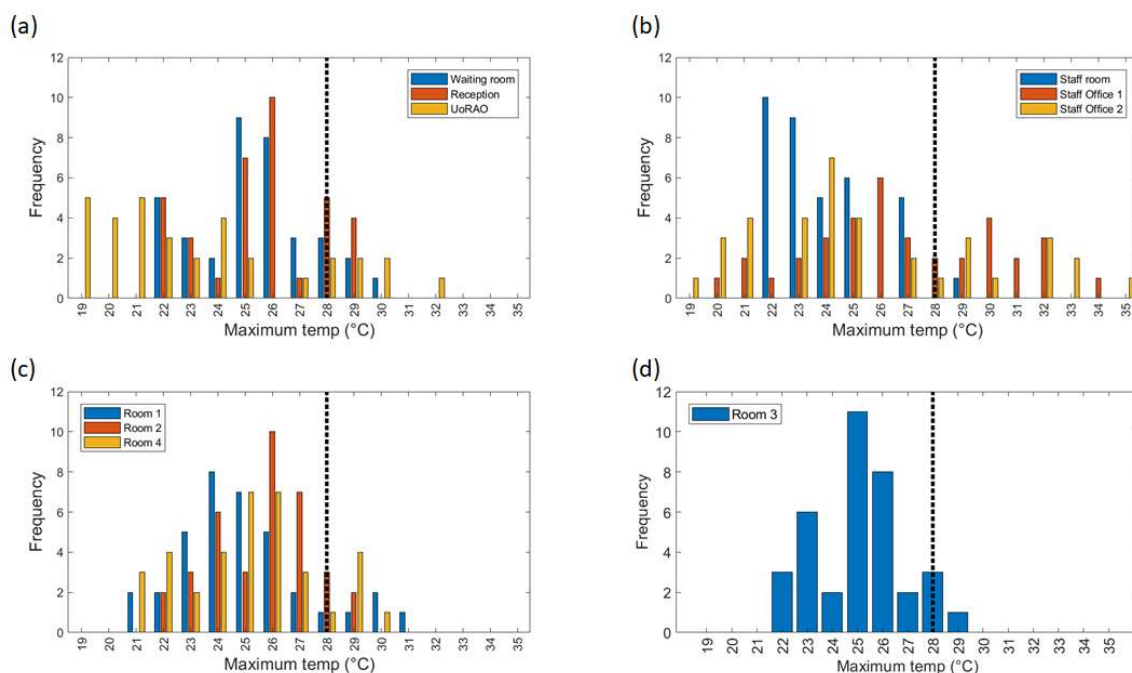
**Figure 9.** Maximum daily temperatures recorded in all rooms across all weekday measurements. For clarity, similar rooms are plotted on one subplot (a) Waiting room, Reception and the observatory (UoRAO), (b) Staff room and Staff offices, (c) Room 1, 2, 4 and (d) Room 3. All plots have the same axis. The vertical dashed line denotes an upper threshold of 28 °C.
